Freightliner  
Service Bulletin

## General Information

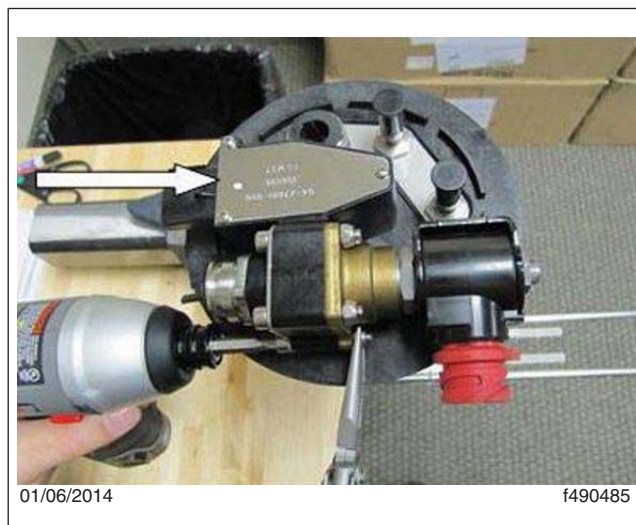
**Fig. 6, Adding a White Dot**

**IMPORTANT:** Units that are manufactured with the new O-rings will have a yellow dot on the ID plate. Units that have had the O-rings replaced should have a white dot on the ID plate. In the event of a leaking solenoid valve, check the unit for a white or yellow dot on the ID plate. See [Fig. 6](#). If the unit being serviced already has one of these, replace the unit with a new one. If the unit does not have a yellow or white dot on the ID plate, replace the O-rings following the instructions in "Replacement" below.

9. Add a white dot to the ID plate to indicate that the valve is reworked. See [Fig. 6](#).
10. Install the DEF tank. For instructions, refer to **Group 49** of the vehicle's workshop manual.
