## Technical Service Note 01-07c

**SUBJECT:** Predictive Cruise Control (PCC) – Module Lockup

**PRODUCTS:** Cascadia units with DBCs 149-037 or 149-041 (Cruise w / Predictive Cruise)

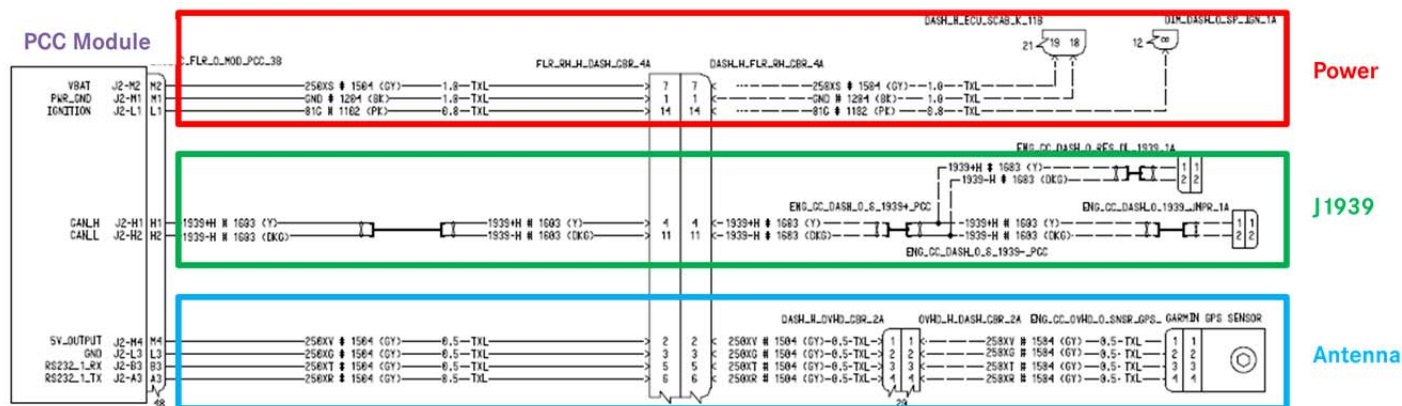
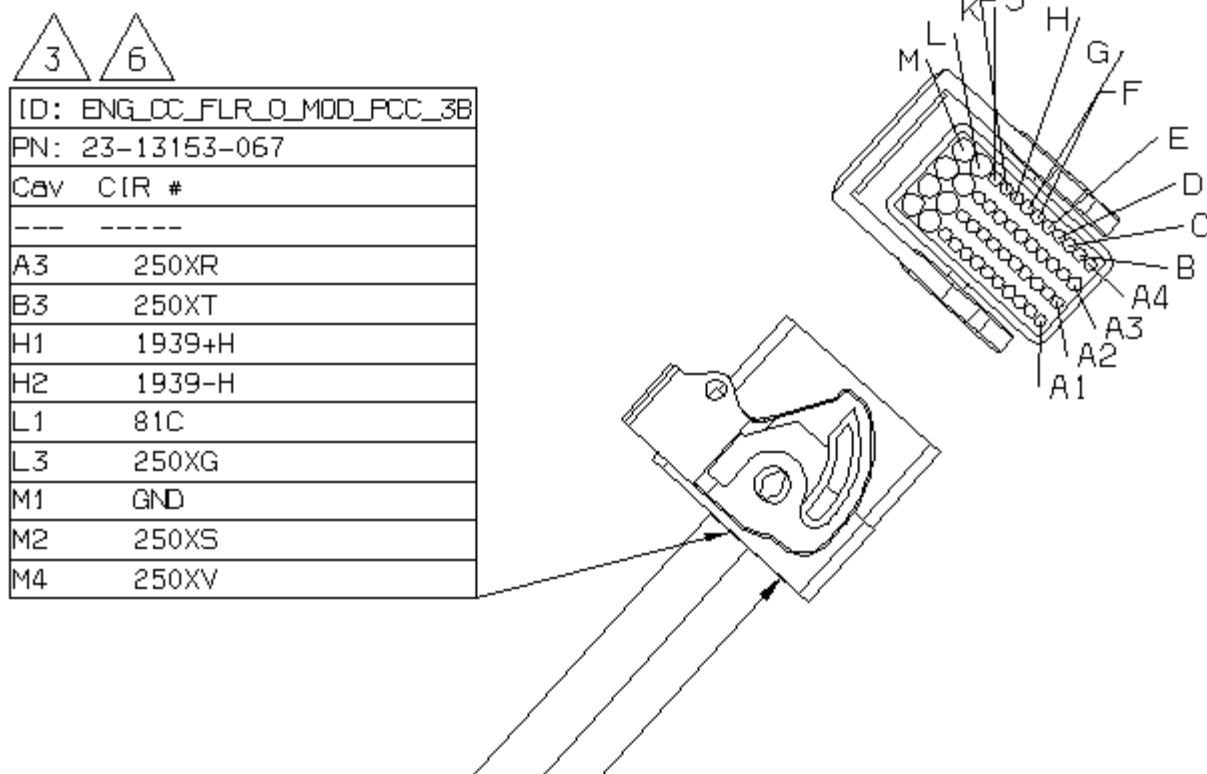
Complete System Schematic  
(G06-77762-000)

**17/841/2 – No GPS Data.** The PCC module generates this code if it does not receive data from the antenna every two minutes. This may occur during normal operation as an historic nuisance code resulting from extended time spent under an overpass, inside a tunnel, or while inside a building (things blocking access to the satellite). Otherwise, as an active code or a high count historic code, pursue as a wiring problem or bad GPS antenna / “sensor”. Check the blue wiring from the system schematic above. For clarification, the circuits are as follows:

250XV = PCC Sensor +5V (where the antenna gets its power from)

250XG = PCC Sensor GND (where the antenna gets its ground from)

250XT = PCC Sensor Transmit (where the antenna sends its information "outbound / transmit" to the PCC module)

250XR = PCC Sensor Receive (where the antenna receives information "inbound / receive" from the PCC module)

If you have 5 VDC at the antenna, and the transmit and receive wires are good, replace the antenna / sensor. If 5 VDC is not present, chase it back to the PCC module and, if it is not putting out, replace the PCC module.
