**Technical Service Note 31-07** (Rev. "A" SN range correction.)

**SUBJECT:** UPS End of Frame (EOF) Crossmember Relocation.

**PRODUCTS:** Cascadia SNs GD8252 through GD8393 (145 Trucks)  
specifying Data Code:  
572-032 HOSTLER 4,000# CAPACITY TOWING REAR CMBR.

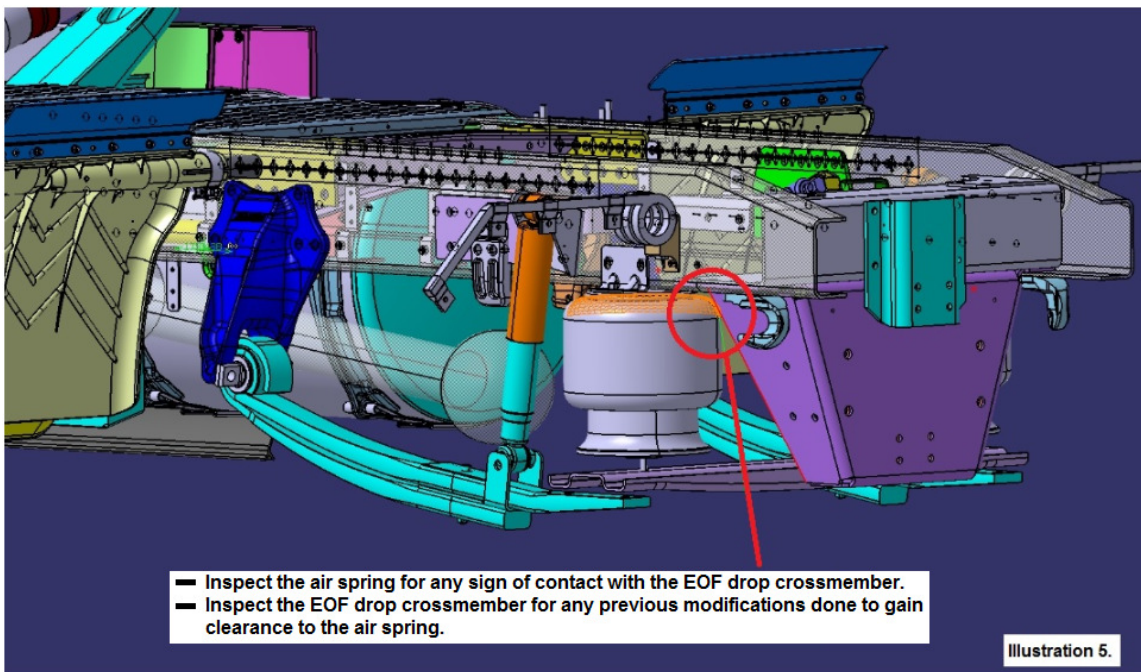
- 5) Inspect the EOF drop crossmember for any previous modification done to gain clearance to the air spring. If the EOF drop crossmember has been modified it must be replaced. Reference Illustration 5.

- 12) Inspect the Airliner rear suspension air spring. If there are any signs of contact between the top of the air spring and EOF crossmember the air spring must be replaced. Reference Illustration 5.
- 13) Clip the airlines and electrical harnesses that were removed to the EOF crossmember assembly. Reference photo 1.
