**Technical Service Note 32-04**

**SUBJECT:** Airliner 21K RH Frame Reinforcements.

**PRODUCTS:** **Customer PODS** Airliner 21K high ride height rear suspension with 9/32" x 80KSI frame rails.

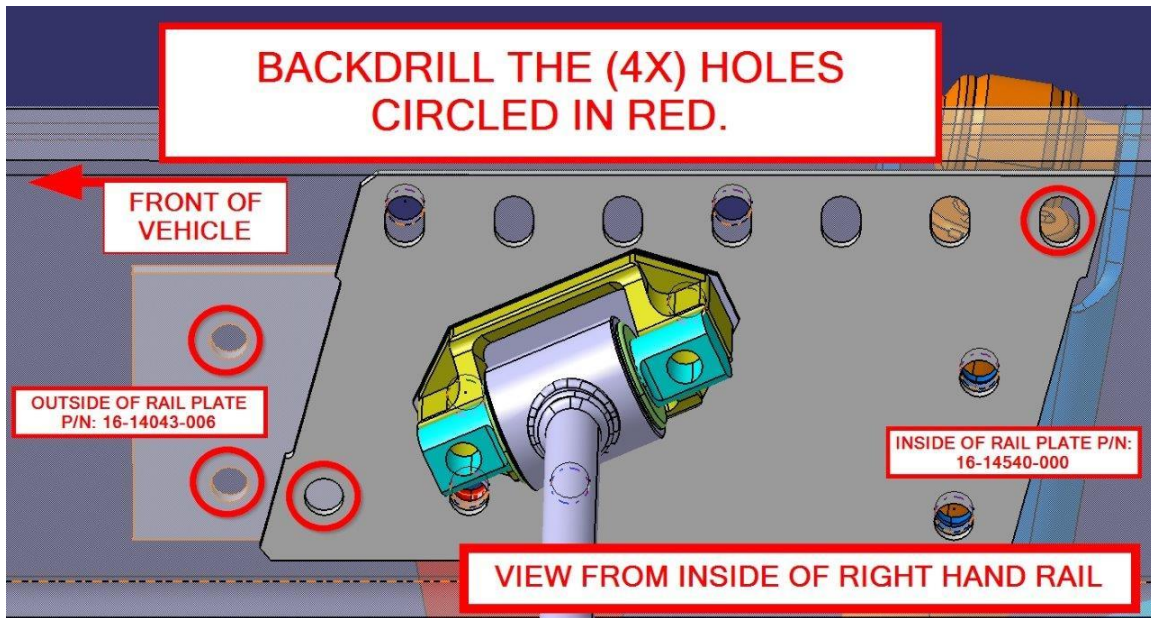
**PROBLEM / SYMPTOMS:** Due to possible overloading of the rear suspension frame failures can occur at the transverse torque rod mounting bracket located on the right hand side frame rail.

- 10) Torque the 5/8" fasteners from the nut side to 128 ft.-lbs.
- 11) From the inside of the frame rail back drill two holes using the inner reinforcement as a template. Reference Illustration 1 and 2.

- 12) From the outside of the frame rail back drill two holes using the outer reinforcement plate as a template. Reference Illustration 1 and 2.
- 13) Bolt up the four holes that were back drilled using 5/8" fasteners and torque 128 ft.-lbs.
