Reference	SSM72108
Models	LR4 / L319
Title	2015 LR4 Instrument Cluster Message Center Display Concern
Category	Electrical
Last modified	11-Dec-2014 00:00:00
Symptom	204000 Instrumentation
Attachments	TO Message Center Display Concern.jpg

2015 LR4

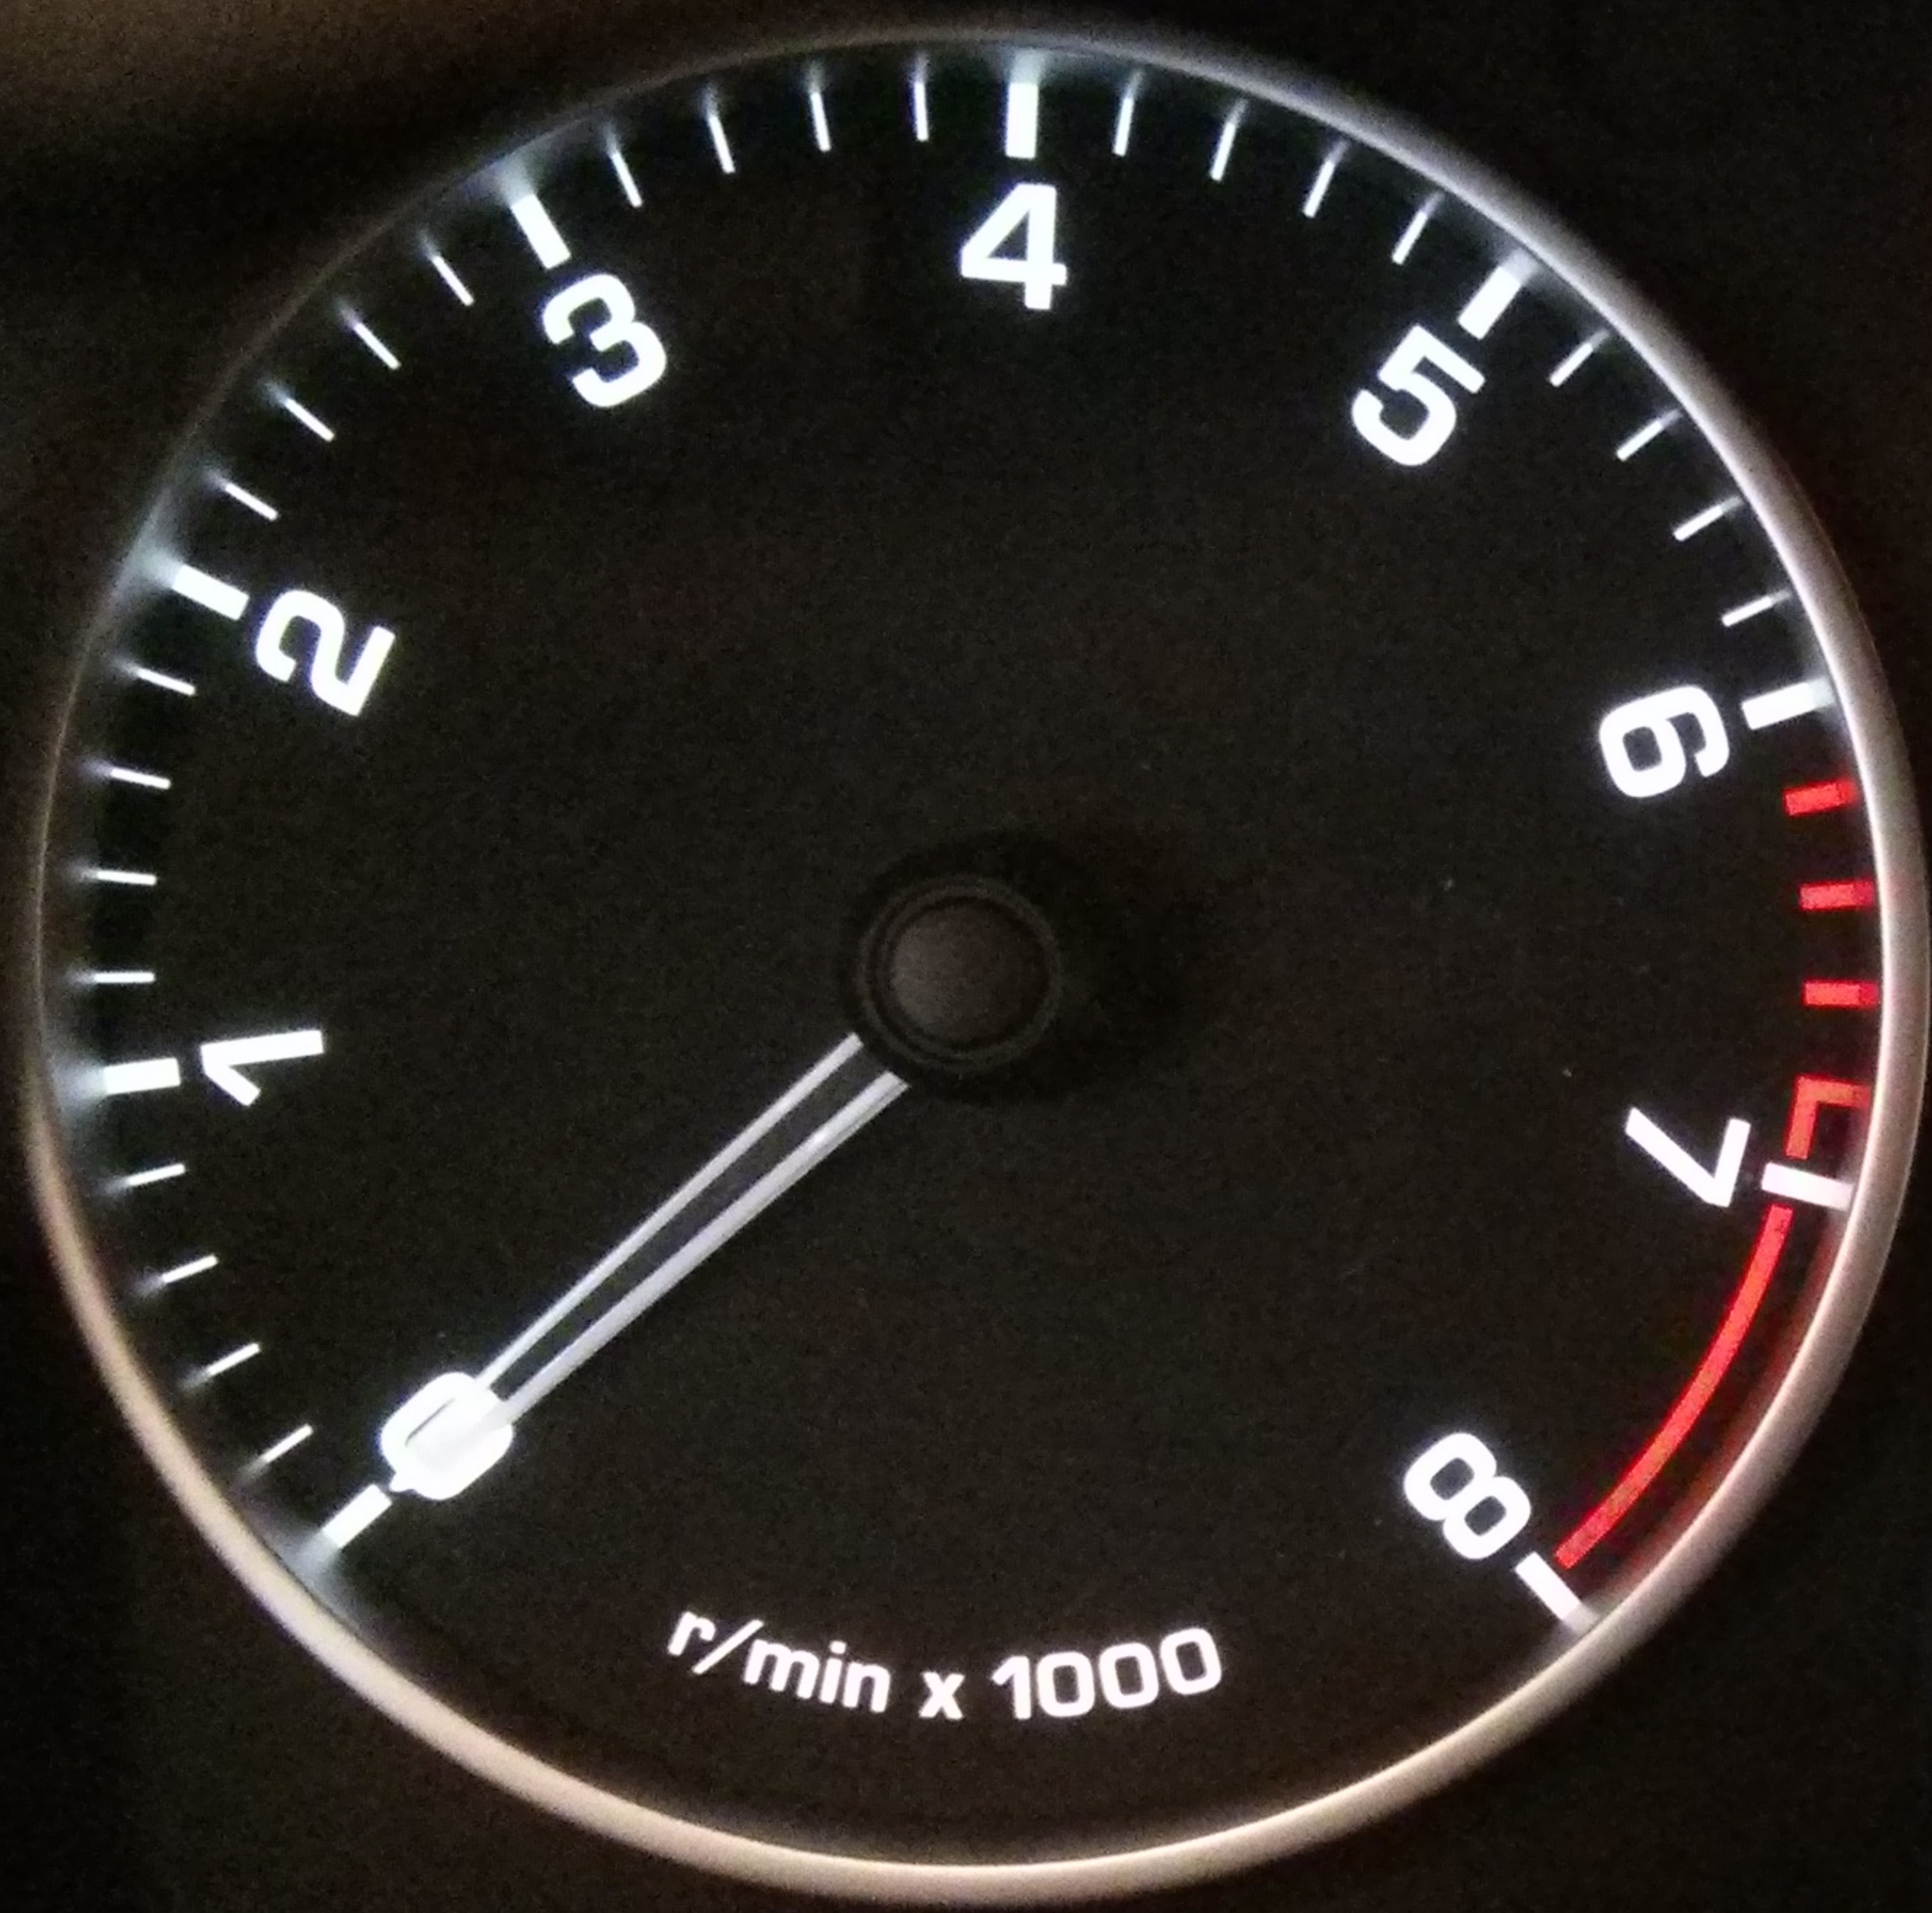
A customer may state their Terrain Optimisation display in the Instrument Cluster Message Center does not correctly match the actual terrain mode which has been selected. Also the text in the Instrument Cluster Message Center, for the selected terrain mode, does not display correctly. "BMP_TR_VEHICLE" is displayed instead of the correct corresponding text for the selected terrain mode.

Instrument Cluster software fault for the "English US" language selection.

For further clarification a photo has been attached showing the described concern.

New Instrument Cluster software is being developed and will be released as soon as possible. A further communication will announce the new software, when it becomes available.

As an interim solution, the customer may select "English UK" from the Instrument Cluster display menu as follows:

Until further notice it is recommended that the UK English language instrument cluster option is selected as a PDI default prior to vehicle delivery and that customers are advised to retain that language option to prevent display concerns.
