TECHNICAL BULLETIN

LTB00618NAS3

'Click' / 'Rattle' Noise From Engine Compartment When Driving

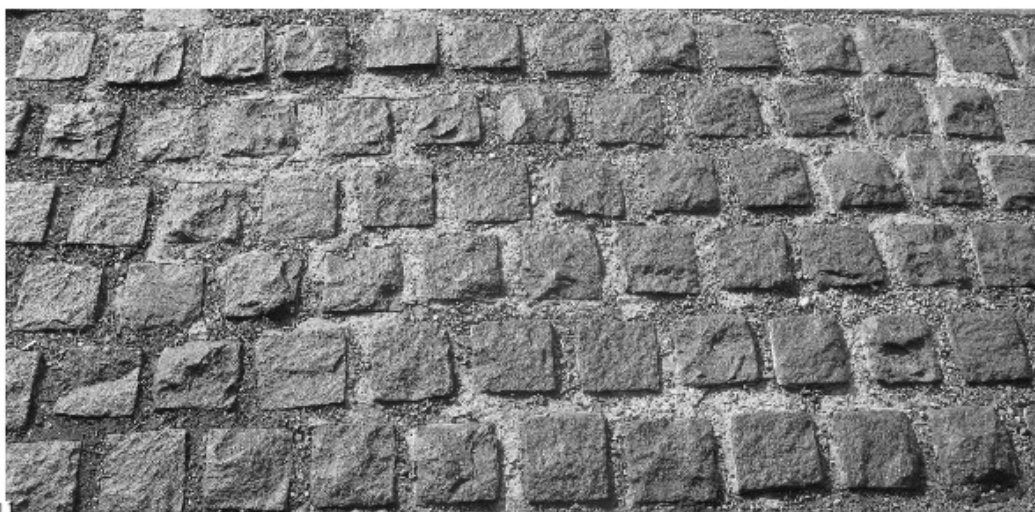
E15961

1. Typical road surface that can generate the 'rattle' sound.

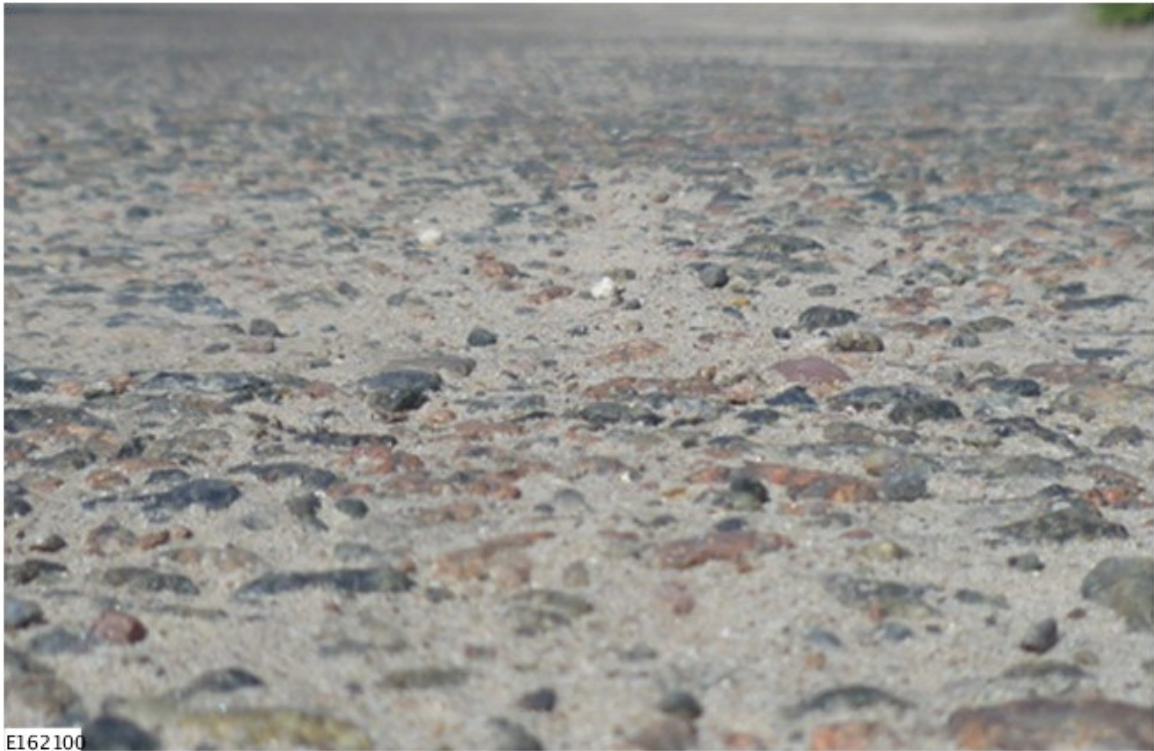
2. Typical road surface that can generate the 'rattle' sound.
