TECHNICAL BULLETIN
LTB00630NAS1
04 FEB 2014

SECTION: 501-12

Front Floor Console Cup Holder Sliding Cover Does Not Latch / Sticks in the Open Position

Range Rover (LG)

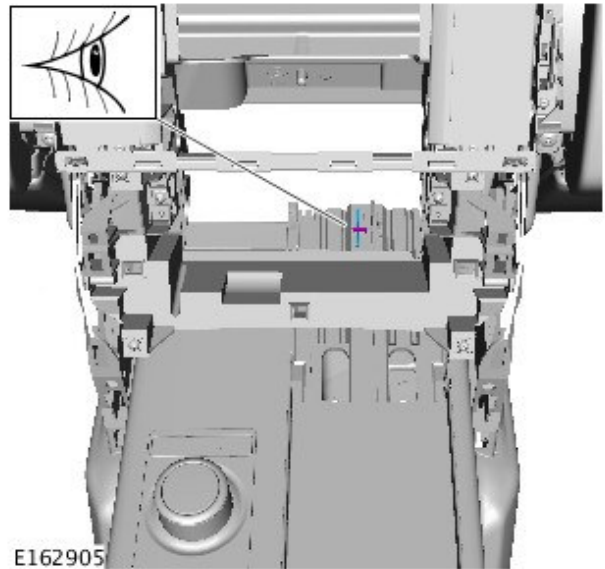
E162905

Situation: The front floor console cup holder sliding cover may not latch or may stick in the open position.

Cause: This may be caused by internal components being not to specification.

11. Locate the cup holder spring.
