# TECHNICAL BULLETIN

## LTB00692NAS1

#### **SECTION: 417-00**

#### **Front / Rear Lamp Condensation - Information Only**

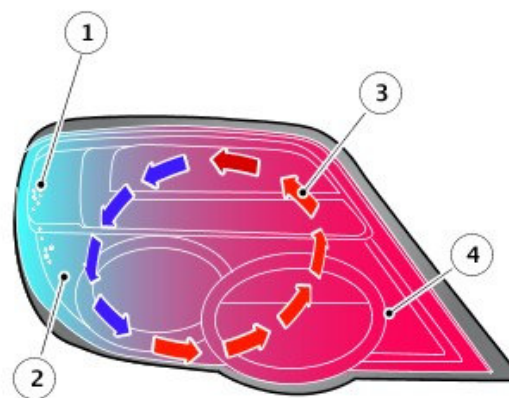
E170120

1. Condensation or moisture can be more noticeable during the months of spring and autumn when there is a likelihood of a higher moisture content in the air. It can occur when there is a temperature difference on either side of the lens surface. This can often be seen in the evening and morning sunshine or when cold water makes contact with a warm lamp lens. When a lamp is warmed unevenly by the sunshine the surface area in direct sunlight will be approximately 10°C higher than the remainder of the lamp. When warm air circulates within the lamp and makes contact with the colder surfaces moisture can appear on the lens as water condenses out of the warmer air. Condensation may occur when washing a vehicle with cold water on a warm day or when the lamps are warm and vice versa. This is the same phenomena as with the formation of dew on the surface of a glass window pane.

1. Moisture formation
2. Cool surfaces
3. Air circulation
4. Warm surfaces

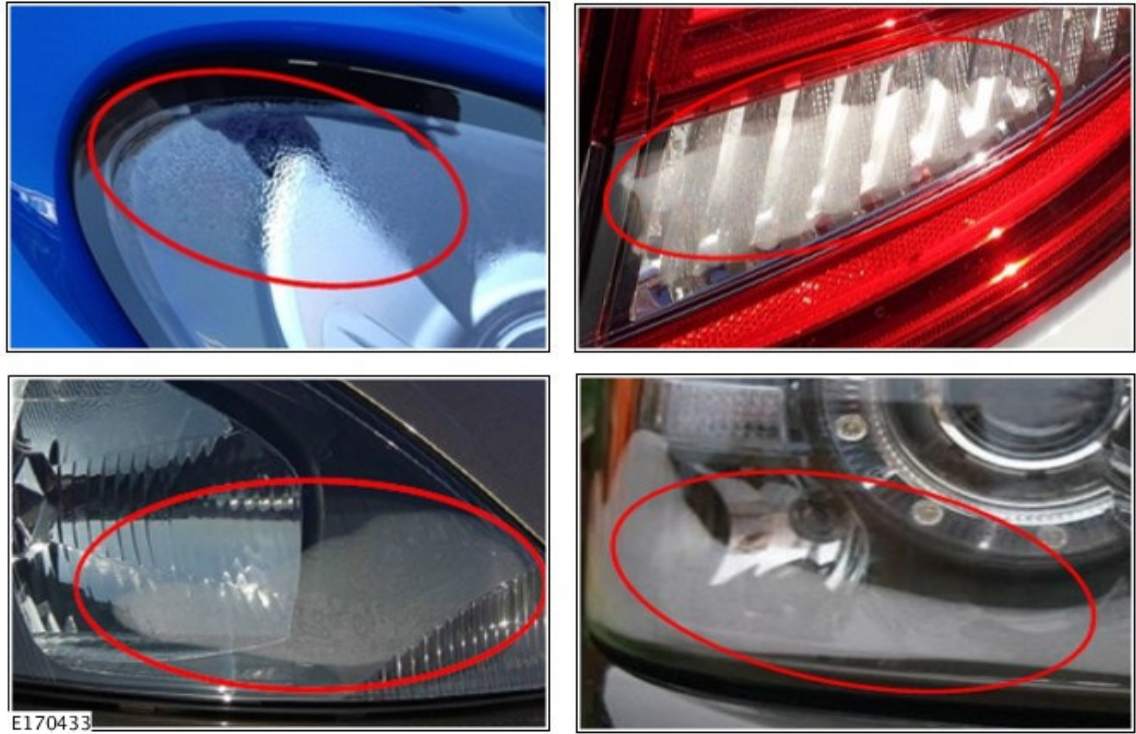
**These are examples of normal exterior lamp condensation. This would NOT be covered by Warranty and the lamp should not be replaced.**

3. No visible streaks, drip marks or droplets in the condensation mist.

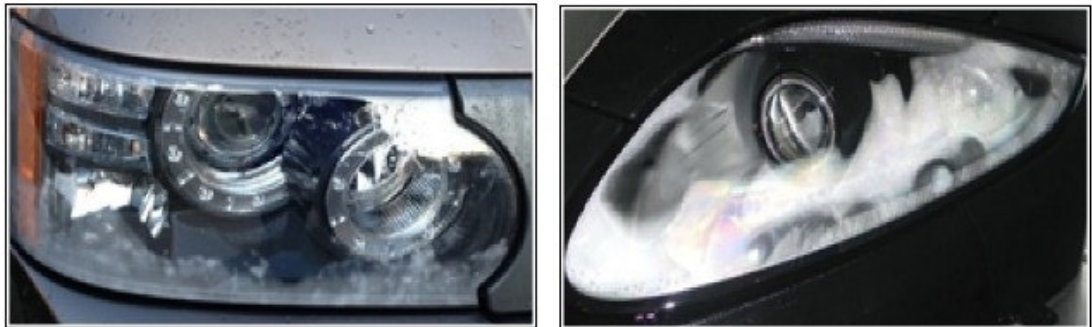
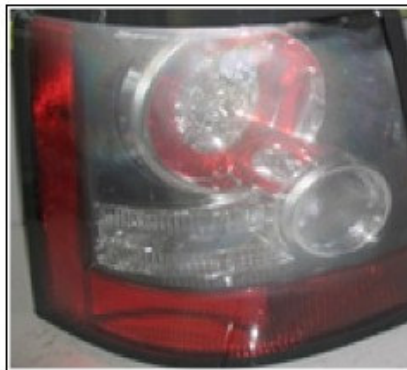
E170434

4. Condensation mist that does not obstruct the view of the lamp interior

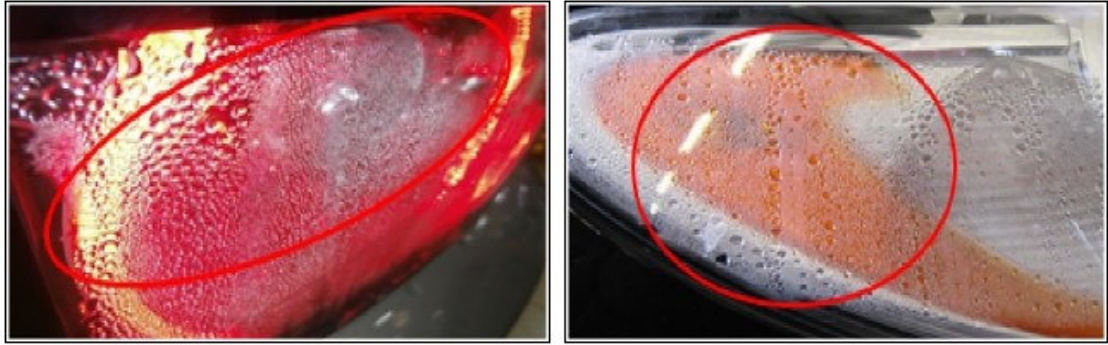
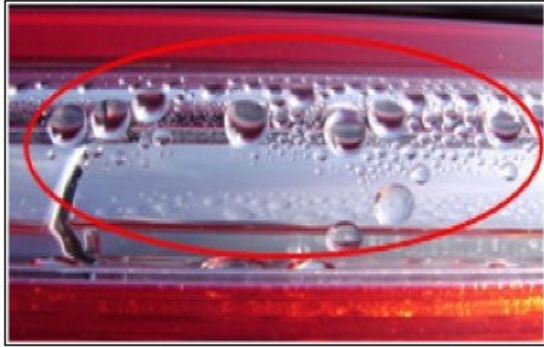
E170435

**These are examples of abnormal exterior lamp condensation that may be covered by Warranty. Warranty may be accepted providing the lamp does not exhibit any visible signs of external damage.**

5. Large water droplets.

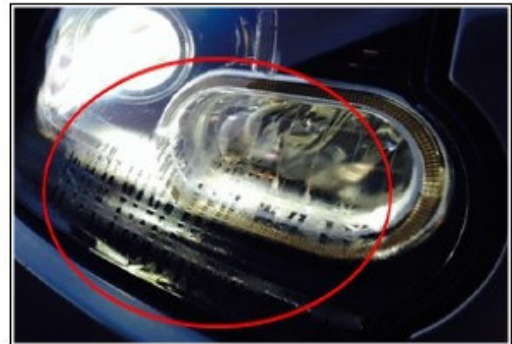
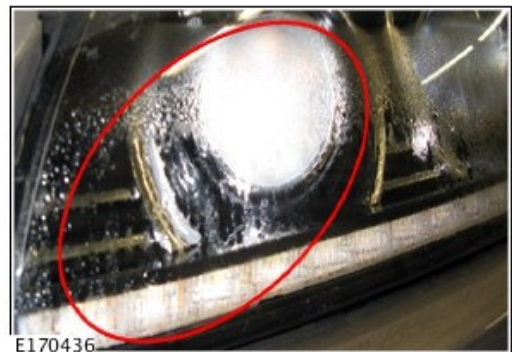
E170436

6. Drip marks or streaks in the condensation.

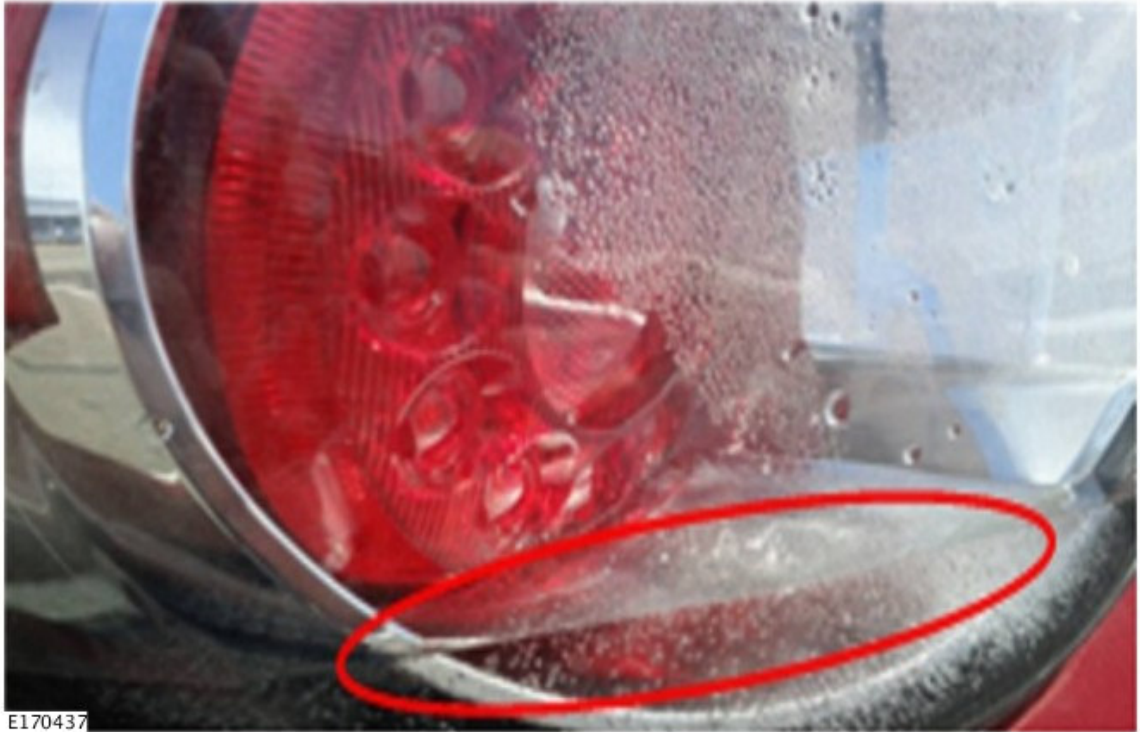
7. Standing water within the lamp.

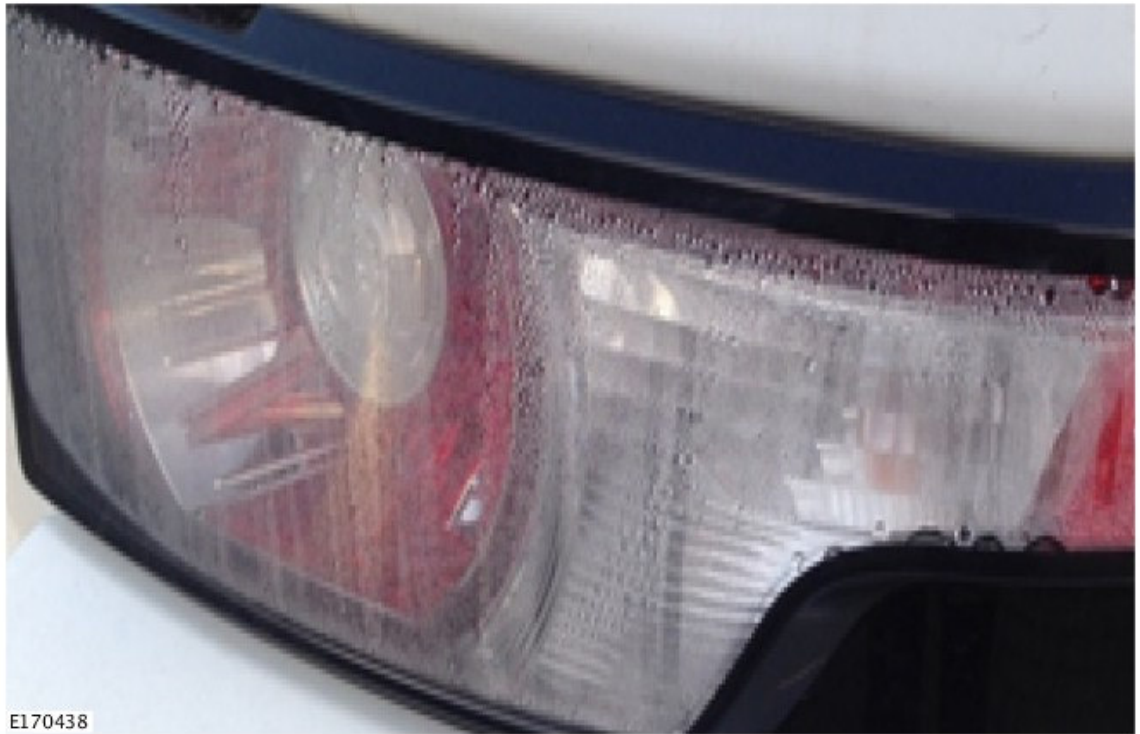
8. A thick mist covering the lens with water droplets.
