TECHNICAL BULLETIN  
P046NAS4  
13 NOV 2014

Safety Recall: Supplementary Restraint System (SRS) Warning Lamp Illuminated

**LR2 (LF)**

**Range Rover Evoque (LV)**

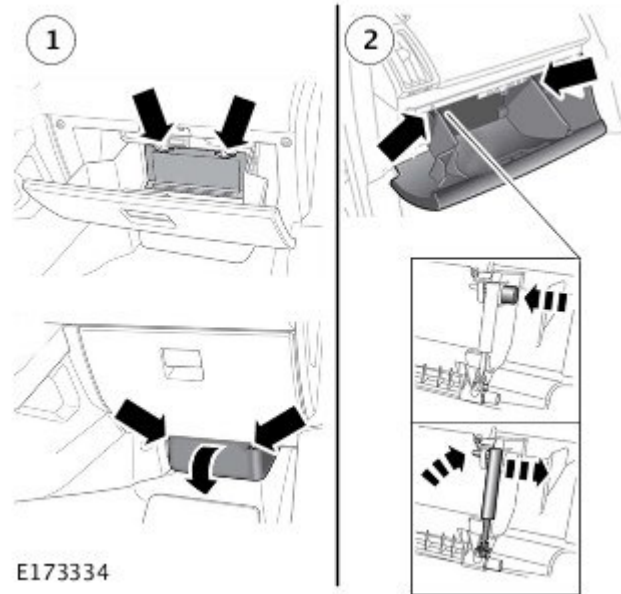
Once the software download parts confirmation screen is presented, remove the OCSCM fuse (fuse number 60; fuse rating 5A).

- The fuse box is located in the passenger compartment:
  - '1' - Range Rover Evoque
  - '2' - LR2
- Press the on-screen green ✓ (tick) to continue.
- Install the previously removed OCSCM fuse when SDD displays a blue scroll bar in the center of the screen.
  - This should be within 10 seconds of pressing the green ✓ (tick) on the software download confirmation screen.
    - If the download is completed successfully, continue to the next step.
    - If the download fails again, please contact your local Technical HelpLine for assistance.
