TECHNICAL BULLETIN  
Q394 UPS3714-2bNAS1  
30 MAY 2014

Update Prior to Sale: Rear Business Seats Harness Trap

<b>Range Rover (LG)</b>		<b>Cab style:</b>	Long Wheelbase
<b>Model Year:</b>	2014	<b>With:</b>	Business Seats
<b>VIN:</b>	EA134173-EA172601

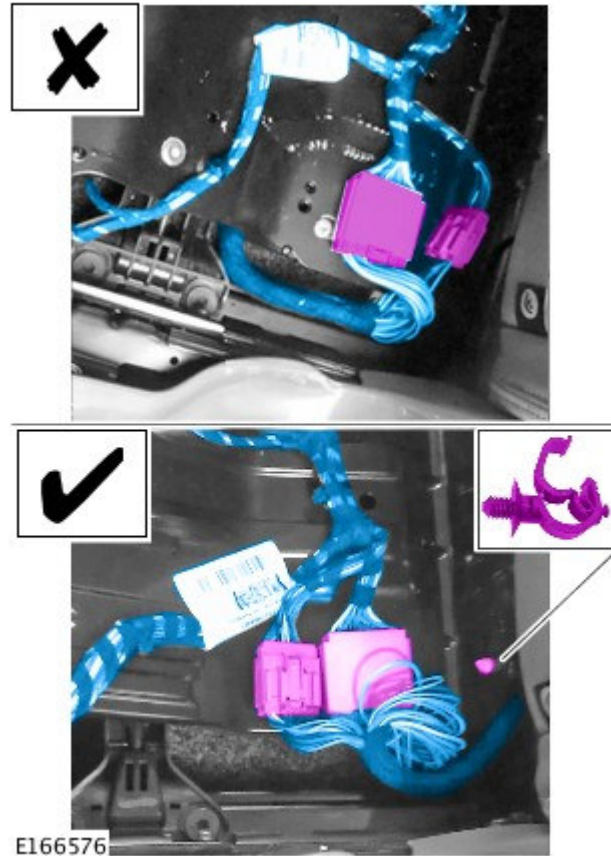
**Situation:** An issue has been identified on 2014 model year Range Rover (L405) Long Wheelbase (LWB) vehicles equipped with rear business seats. There is a risk of wiring harness contact with the rear left and right business seat mechanism, leading to a possible chafing condition at the breakout to the rear seats and causing the seat(s) to not function properly.

1. Remove rear left-hand business seat for access (see TOPIx Workshop Procedure, section 501-10).
  - Remove seat cushion.
2. Check to see if the seat harness is routed correctly.
