L-SB-0001-14

January 6, 2014

Navigation System Firmware Update

YEAR(S)	MODEL(S)	ADDITIONAL INFORMATION
2014	GX460

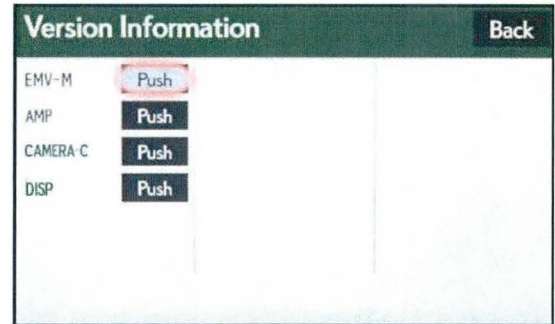
Figure 6.

G. Confirm current version is older than new version.

- If the current version is V12A8110 or greater, **STOP** – this bulletin does NOT apply.
- If the current version is less than V12A8110, proceed to the next step.
