# TECHNICAL BULLETIN

## LTB00348NAS3

## Water Ingress Through High-Mounted Stop Lamp

#### **LR2 (LF)**

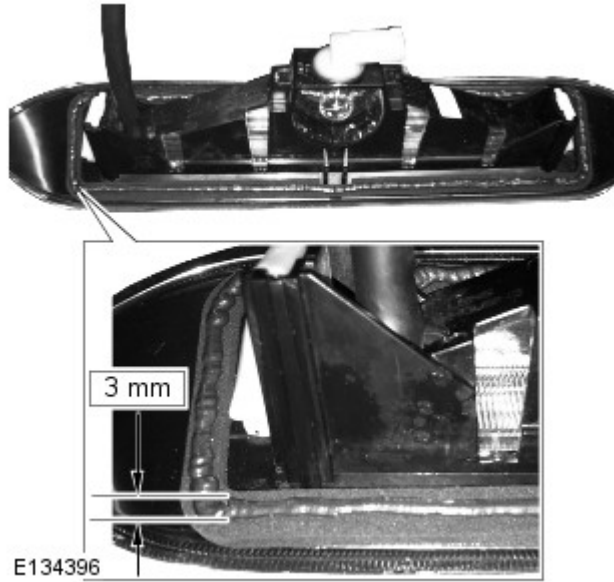
**Situation:** Water may enter the vehicle through the high-mounted stop lamp area.

**Cause:** This may be caused by water passing through the high-mounted stop lamp seal.

3. Apply a 3mm bead of PU Sealant STC50550 to the sealing face of the high-mounted stop lamp foam seal.
