TECHNICAL BULLETIN
LTB00507NAS2
14 MAR 2014

Loadspace Cover-To-Tailgate Contact Repair

Range Rover Evoque (LV)

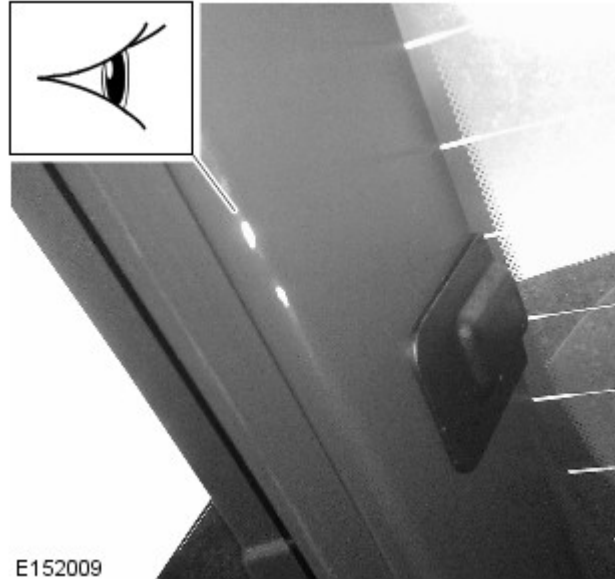
1. Identify damaged area.

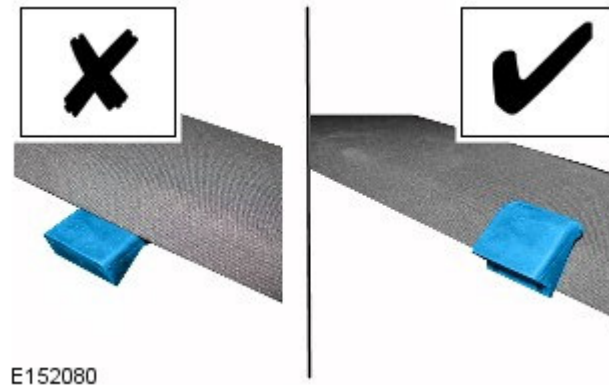
**NOTE: The tangs shown are those which are part of the tailgate.**

Loadspace cover in the possible foul condition ('X') and also in the correct position ('tick').

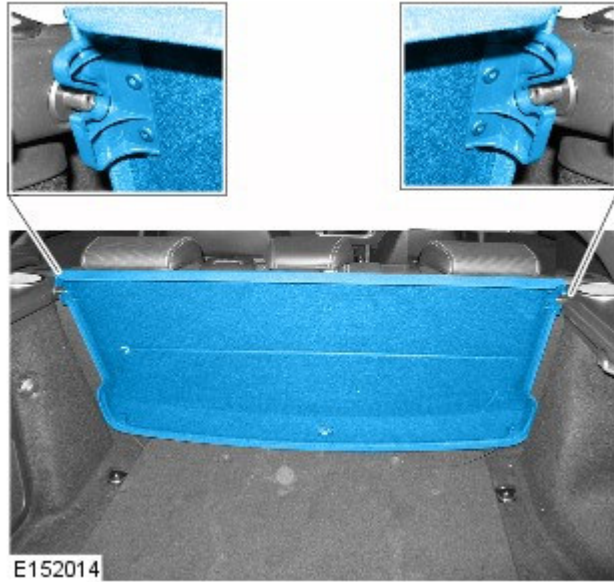
Loadspace cover shown in stowed position.

**NOTE: The loadspace cover may become incorrectly seated if the loadspace area is overloaded. Should this occur, advise the owner about the loadspace cover stow position shown. Refer to Owner's Handbook for further information.**
