TECHNICAL BULLETIN  
K219NAS1  
25 FEB 2014

Service Action: Power Cable Through-Panel Stud

<b>XK Range (X150)</b>	
<b>Model Year:</b>	2014
<b>VIN:</b>	B53580-B54243

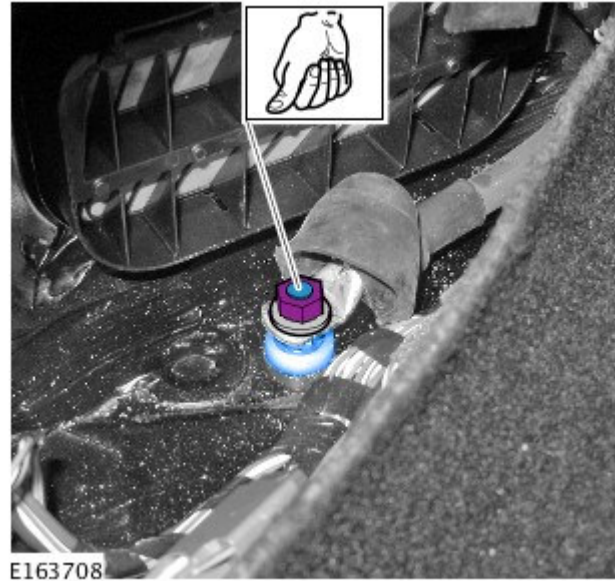
4. Loosen but do NOT remove the securing nut from

the stud.

- Apply downward pressure to the stud.
  - If the stud does not move downwards, carry out Procedure 1.
  - If the stud does move, in a downward direction, carry out Procedure 2.
