TECHNICAL BULLETIN
K225NAS1
02 SEP 2014

Service Action: Charge Air Cooler Duct Bolt Torque Relaxation

XF (X250)			
Model Year:	2013	Engine:	GTDi 2.0L Petrol
VIN:	S51675-U00808

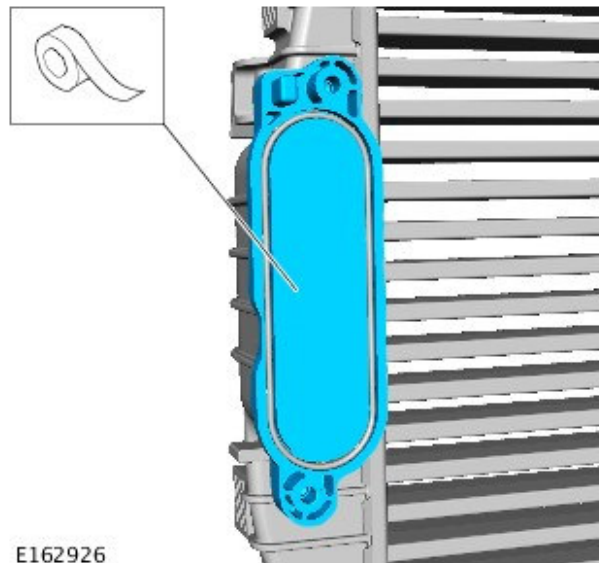
**NOTE: Charge air cooler end tank outlet shown; inlet similar.**

Tape over the charge air cooler end tank outlet opening to prevent any swarf/ dirt from entering the charge air cooler.

- Repeat to the charge air cooler end tank inlet.

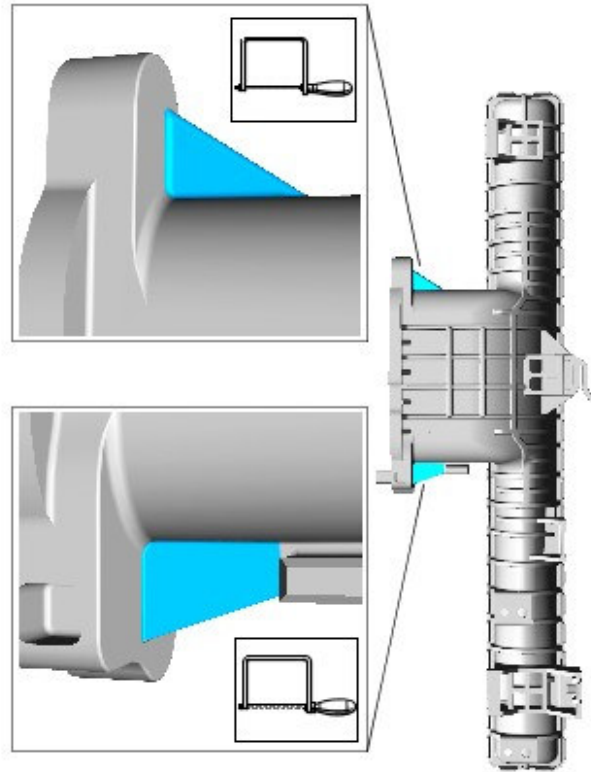
E162923

**NOTE: Charge air cooler end tank inlet shown; outlet similar.**

Cut out the highlighted sections of the charge air cooler end tank inlet as shown.

- Repeat to the charge air cooler end tank outlet.

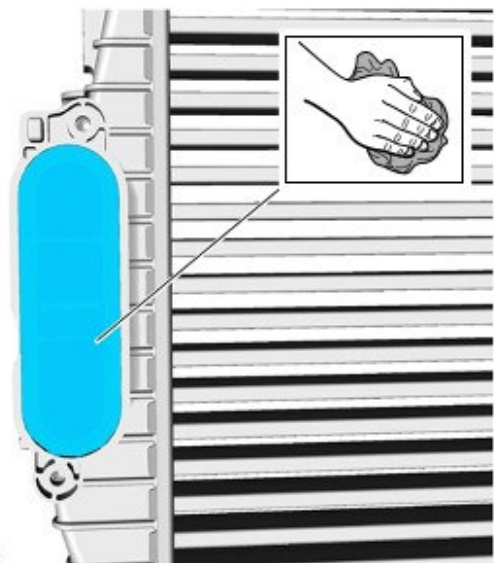
E160429

**NOTE: Charge air cooler end tank outlet shown; inlet similar.**

Clean away all debris before removing the protective tape from the charge air cooler end tank outlet.

- Repeat to the charge air cooler end tank inlet.

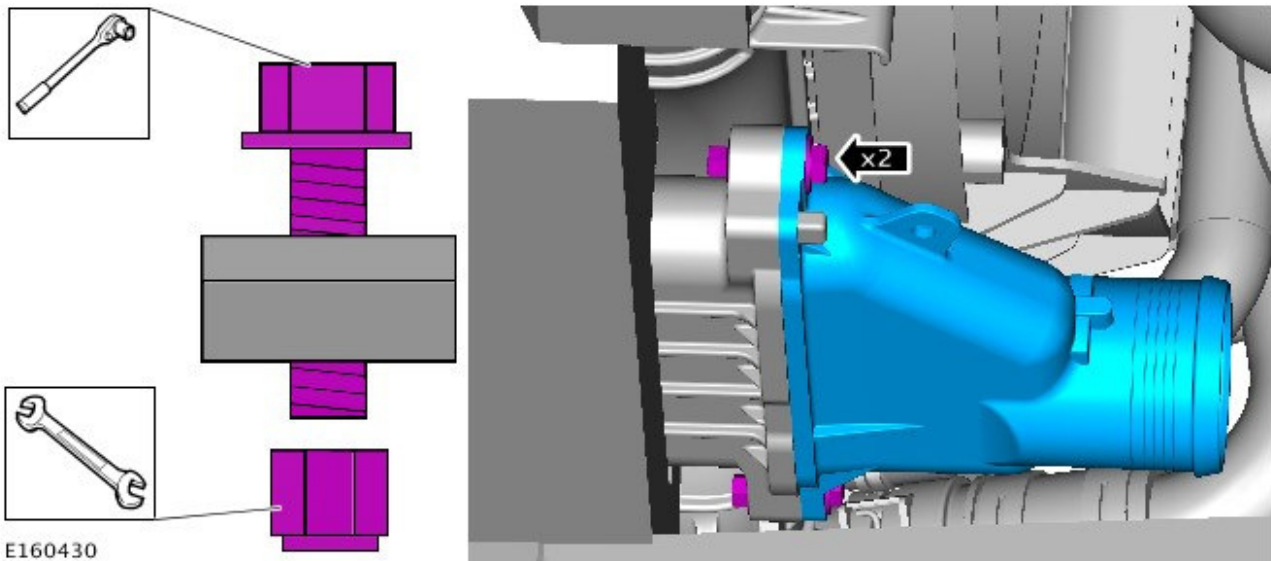
**NOTE: Make sure the rubber sealing gasket between the duct and the charge air cooler is correctly**

positioned.

**NOTE: Make sure the washer is next to the bolt head, to prevent any damage to the plastic charge air cooler end tank during the tightening process.**

Using the bolt/washers and locknuts, install the charge air cooler end tank outlet duct to the charge air cooler end tank outlet.

- Tighten to 7Nm.
