TECHNICAL BULLETIN K251NAS1 16 SEP 2014

Service Action: Parcel Shelf 'Creak' Noise When Closing Luggage Compartment Lid

F-TYPE (X152)

Model Year: 2015 Body style: Coupe

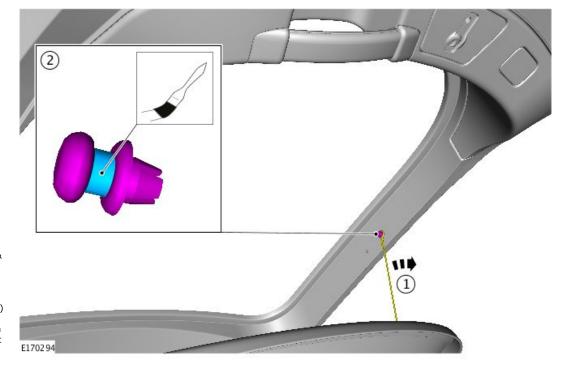
Situation: An issue has been identified on a limited number of 2015 model year F-TYPE (X152) vehicles (Coupe only) where the parcel shelf cords may exhibit a 'creak' noise when closing the luggage compartment lid.

> Lubricate the right-hand parcel shelf cord luggage compartment lid stud.

- Release the right-hand parcel shelf cord from the
- cord from the luggage compartment lid stud. Using PEOX AC612/12 grease (from the Squeaks & Rattles Kit; refer to Technical Bulletin Bulletin JTB00231NAS) and a soft brush, apply a liberal amount of grease around the entire running face of the parcel shelf cord luggage compartment stud.
