TECHNICAL BULLETIN K251NAS2 17 NOV 2014

Service Action: Parcel Shelf 'Creak' Noise When Closing Luggage Compartment Lid

F-TYPE (X152) Model Year: VIN:

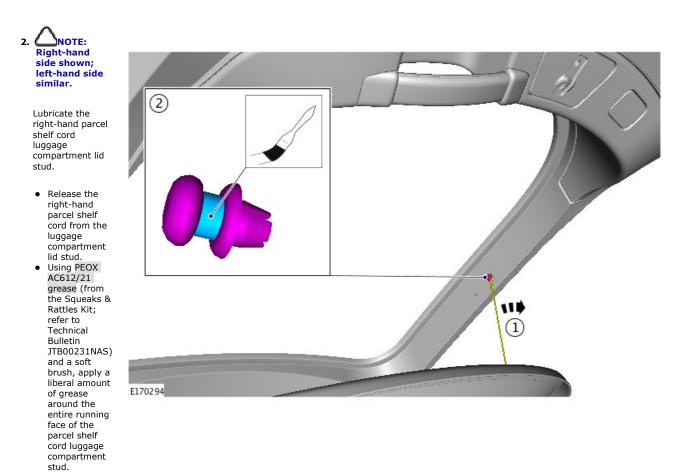
Situation: An issue has been identified on a limited number of 2015 model year F-TYPE (X152) vehicles (Coupe only) where the parcel shelf cords may exhibit a 'creak' noise when closing the luggage compartment lid.

- 3. Repeat step 2 to the left-hand parcel shelf cord luggage compartment stud.
- 4. Close and open the luggage compartment lid three (3) times, ensuring no 'creak' noise is evident.
- 5. Close the luggage compartment lid.
