TECHNICAL BULLETIN
K214 UPS0114-4bNAS1
18 JUN 2014

Update Prior to Sale: Door Sill Applique

F-TYPE (X152)

Model Year: 2014
VIN: K00001-K08070

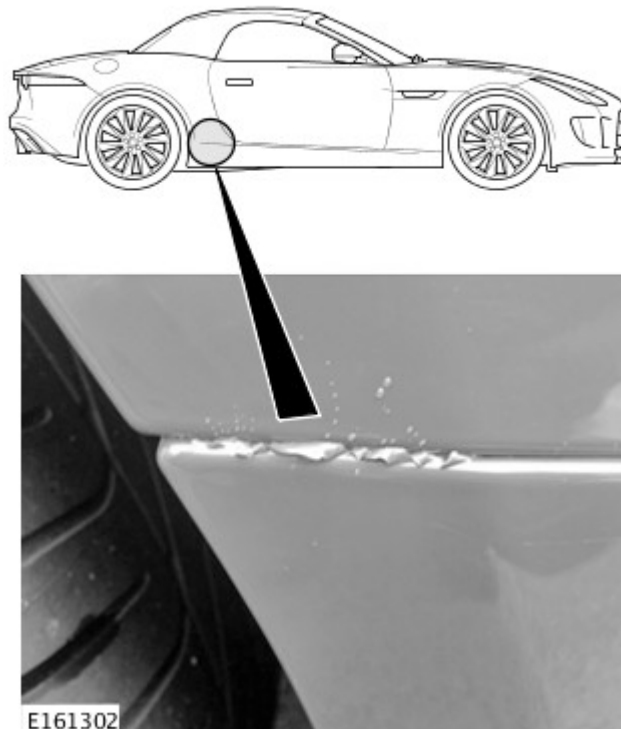
1.

Situation: A potential issue has been identified on 2014 model year F-TYPE (X152) vehicles within the listed VIN range where paint is not adhering to the rear panels and that the paint is peeling where the sill meets the rear quarter.

Identify the area of damage.

2. Remove the rocker panel moulding (see TOPIx Workshop Manual, Section 501-08).
3. Repair and paint the damaged area on the rocker sill moulding.
4. Remove the three (3) mounting bracket bolts.
