TECHNICAL BULLETIN  
J047NAS1  
10 NOV 2014

**Safety Recall: Seatbelt Tension Sensor Connector Wiring**

**F-TYPE (X152)**

**Model Year:** 2014-2015  
**VIN:** K00001-K19747

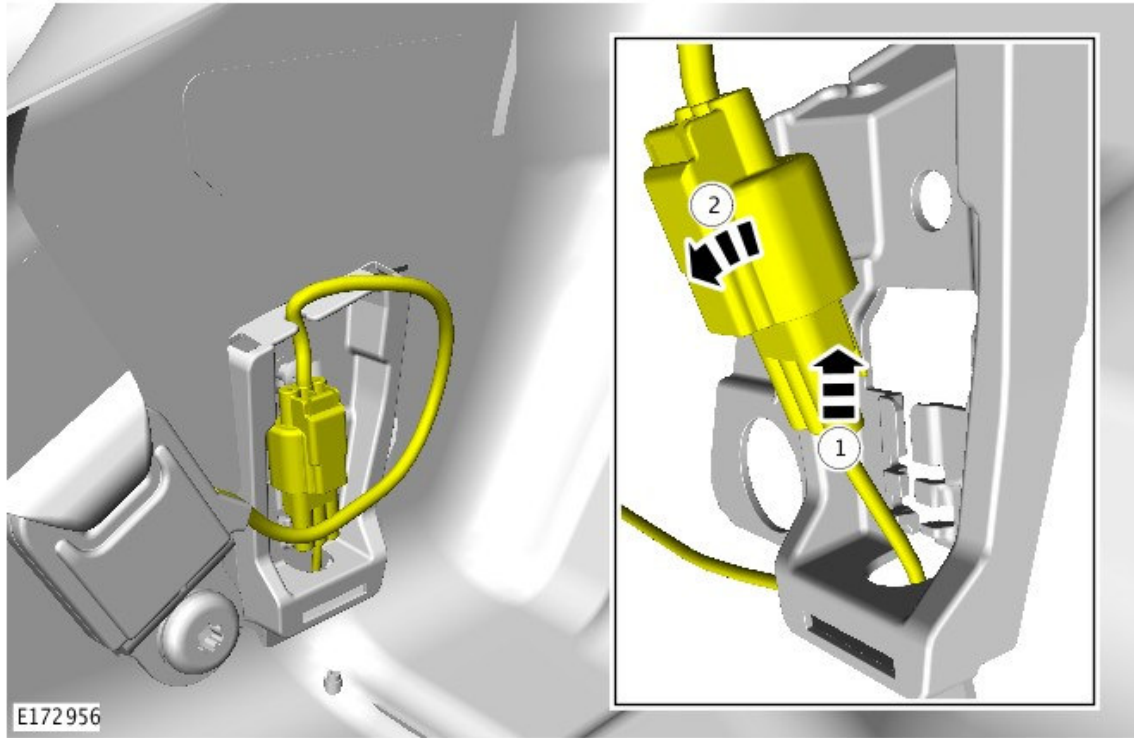
4. At the Seatbelt Tension Sensor side of connector C3R210, check that the electrical connector wires are positioned in the correct pin location as shown.

- If the wires are in the correct position, reverse steps 1-3 and release the vehicle.
- If the wires are not in the correct position, proceed to step 5.
