TECHNICAL BULLETIN  
J047 UPS8014-3bNAS1  
31 OCT 2014

Update Prior to Sale: Seat Belt Tensioner System Connector Wiring

**F-TYPE (X152)**

**Model Year:** 2014-2015  
**VIN:** K00074-K19728

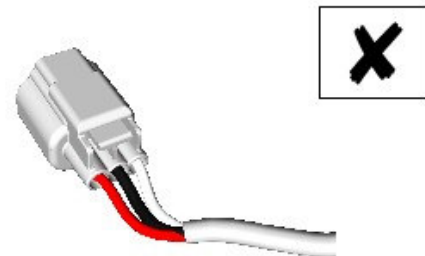
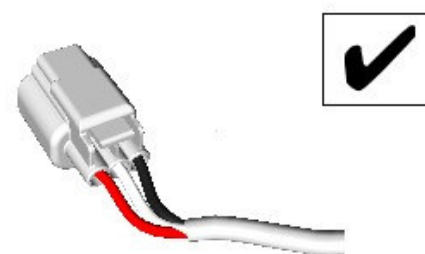
E172955

**Situation:** An issue has been identified with the wiring connecting the passenger seat belt tensioner system to the main cabin wiring harness, and it is possible that the seat belt tensioner system may not correctly sense the presence of a child restraint or very light weight occupant.

**5.** At the Seatbelt Tension Sensor side of connector C3R210, check that the electrical connector wires are positioned in the correct pin location as shown.

- If the wires are in the correct position, reverse steps 1-4 and release the vehicle.
- If the wires are not in the correct position, proceed to step 6.
