NUMBER: 23-011-14 REV. A

Left Rear Sliding Door Weatherstrip Seal Sticks Out At Bottom Of C-Pillar Door Opening

2014 RT Caravan / Town & Country

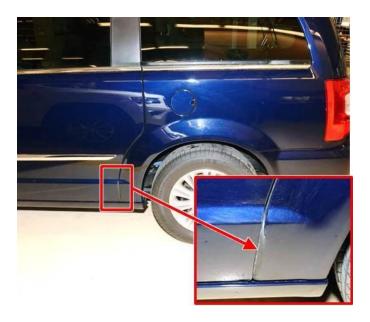
Some vehicles may have a left rear sliding door weatherstrip seal that sticks out along the C-pillar side of the door opening as shown in (Fig. 1).

- 1. **Is the left rear sliding door weatherstrip seal sticking out along the C-pillar side of the door opening as shown in (Fig. 1)?
 - a. YES >>> Continue with Step #2.
 - b. No >>> No further action is required. This bulletin does not apply.**

Fig. 1 Symptom Condition Area Of Concern

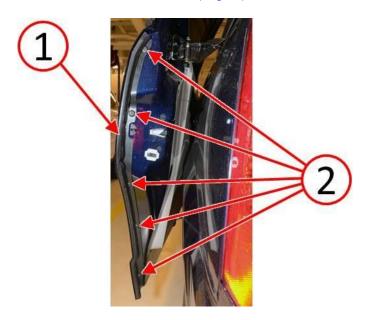
Fig. 2 Door Weatherstrip Seal Replacement

2. Replace the weatherstrip seal on the left rear sliding door with the seal specified in the PARTS REQUIRED section of this bulletin (Fig. 2).

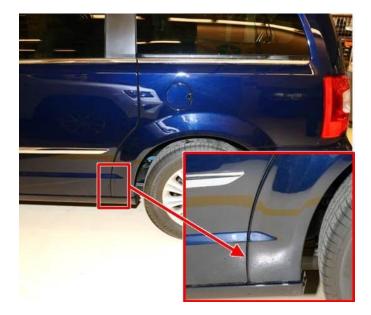
Fig. 3 Symptom Condition Corrected

3. Verify that the symptom/condition has been corrected as shown in (Fig. 3).
