NUMBER: 23-001-14 REV. A

Wind Noise Left Front Door

2013 - 2014 (JS) Avenger

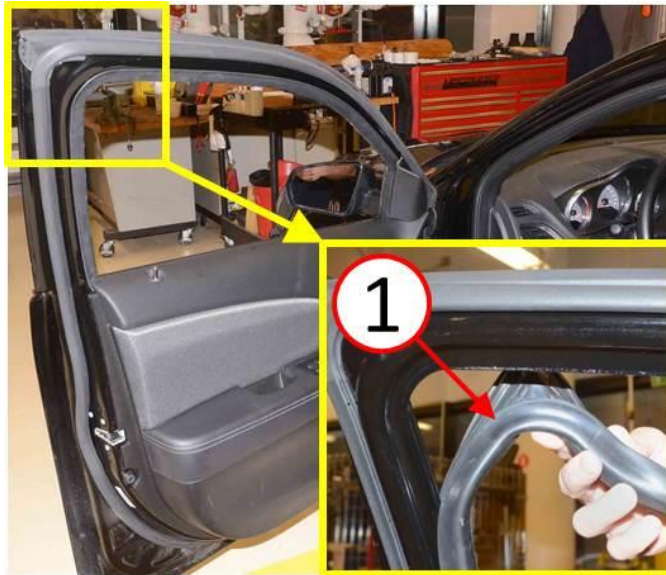
Fig. 1 Remove Window Run Channel Seal

1 - Window Run Channel Seal

1. Lower the left front door window.
2. Remove the window run channel seal from of the upper B-pillar corner of the left front door window run channel (Fig. 1).

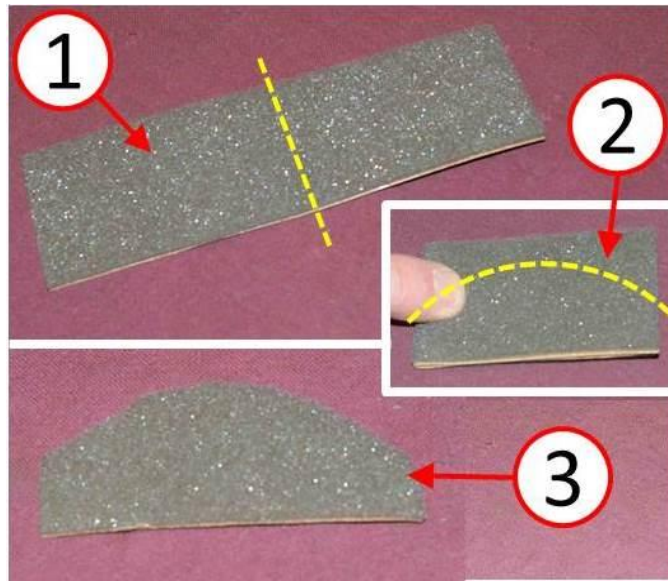
Fig. 2 Cut Foam Piece

- 1 - Full Foam Piece
- 2 - Half Foam Piece
- 3 - Contoured Foam Piece

-
3. Cut the foam piece in half (1). Trim one half of the foam piece (2) to match the contour (3) of the upper window run channel corner (Fig. 2).

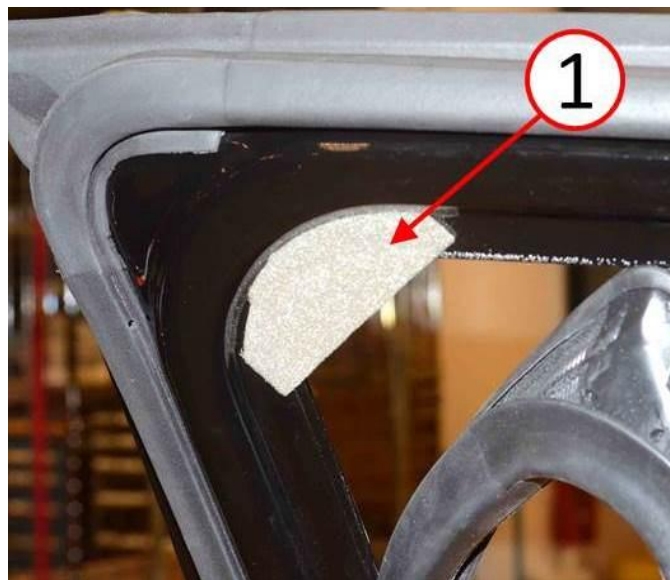
Fig. 3 Foam Piece Installed

- 1 - Contoured Foam Piece
-

-
4. Install the contoured foam piece in the upper B-pillar corner of the left front door window run channel. The foam piece curved contoured edge should not extend beyond the area covered by the window run channel seal ([Fig. 3](#)).

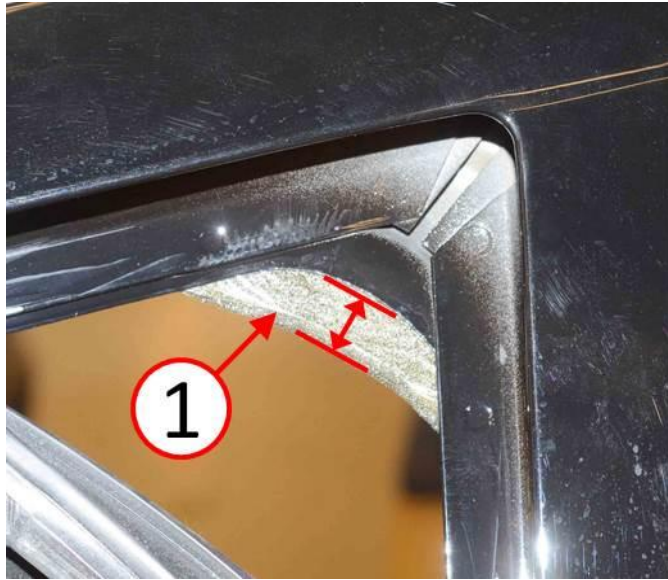
Fig. 4 Foam Piece Overlap

1 - Foam Piece Overhang

5. As viewed from the outside of the door, the foam piece should extend beyond the corner by approximately 13 mm (0.5 In.) ([Fig. 4](#)).

NOTE: Do NOT trim or remove this excess foam tape, it will compress upon installation of window run channel seal.

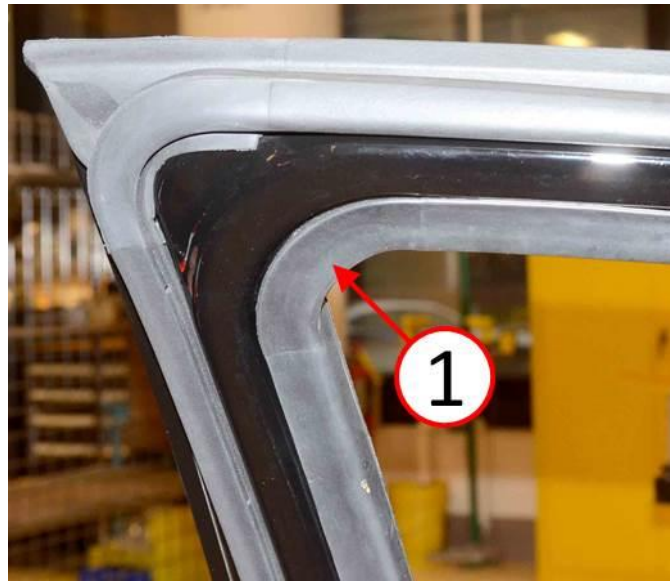
Fig. 5 Install Run Channel Seal

1 - Window Run Channel Seal

6. Reinstall the window run channel seal to the door window run channel ([Fig. 5](#)).
