NUMBER: 19-004-14

GROUP: Steering

Excess Leather On The Steering Wheel

(LX)

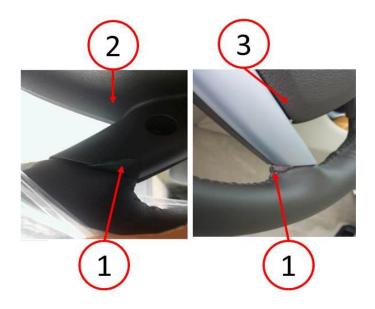
Fig. 1 Steering Wheel

Excess leather on the steering wheel.

- 1 Excess Leather
- 2 Backside of Steering Wheel
- 3 Front of Steering Wheel

- 1. Inspect the steering, is there excess leather as shown in (Fig. 1).
 - a. Yes>>> Remove and replace the steering wheel, Refer to the detailed service procedures available in DealerCONNECT> TechCONNECT under: Service Info> 19
 Steering> Column> Wheel, Steering> Removal/Installation.
 - b. No>>> Return the vehicle to the customer or dealer inventory.
