**GROUP:** Front Suspension

Front End Clunk Noise When Coming To A Stop - Mexico Only

2011 - 2012	(LD)	Dodge Charger
2011 - 2012	(LE)	Dodge Charger (Export)

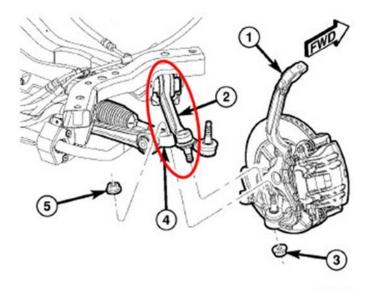
# Fig. 1 Tension Strut Replacement

The customer may experience a front end clunk noise, coming from the tension strut bushing(s), when coming to a stop.

1. Replace both the left and right side tension struts. Refer to the detailed procedures available in DealerConnect>TechCONNECT> under: Service Info> 02 - Front Suspension> Front> STRUT, Tension, RWD> Removal/Installation.
