NUMBER: 21-013-14

Transmission Oil Cooler Tube

This bulletin involves inspecting the transmission oil cooler tubes, power steering return tube and if necessary installing a protective sleeve on the transmission oil cooler tube.

2012-2013 (JK) Wrangler

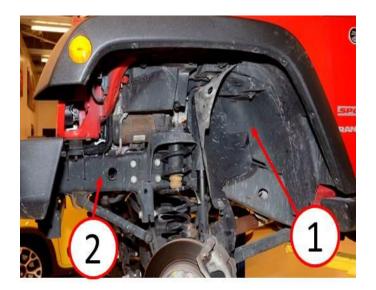
Fig. 1 Splash Shield

- Remove and save the left front wheel and tire assembly.
 Partially remove the left front wheel liner to gain access to the transmission oil cooler tube and power steering return tube (Fig.1).

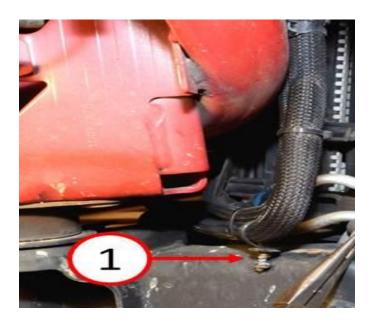
Fig. 2 Power Steering Hose Retainer

3. Disengage the power steering hose retainer from the left frame rail (Fig.2).

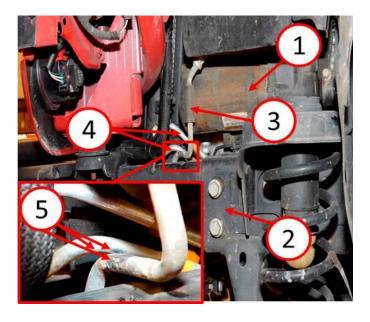
Fig. 3 Inspect TOC Tube

- 4. Using a small inspection mirror, check for wear marks on the transmission oil cooler tube and power steering return tube where they intersect. Were there any wear marks on the transmission oil cooler or power steering return tube (Fig.3)?
 - a. Yes>>> Contact a STAR agent for further assistance at 1-800-850-STAR, select "Part or Labor Operation Restriction". Enter part number (digits only) for part number CBRAN283AA (digits 283).
 - b. No>>> Proceed to Step 5.
