NUMBER: 23-023-14

DATE: September 11, 2014

Metallic Rattle Noise From The Roof Headliner Area

2014 (DS) 1500 Pickup

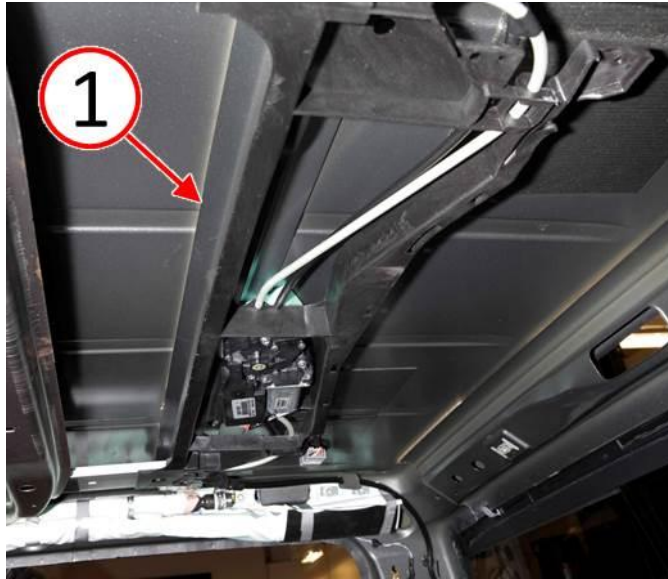
Fig. 1 Roof Bow Inspection Location

4. Lower the headliner and rest on the front seat headrests. Refer to the detailed service procedures available in DealerCONNECT> TechCONNECT under: Service Info> 23 - Body> Interior> HEADLINER> Removal.
5. Slide the sunroof shade forward, to expose the roof bow (1) ([Fig. 1](#)).

1 - Roof Bow

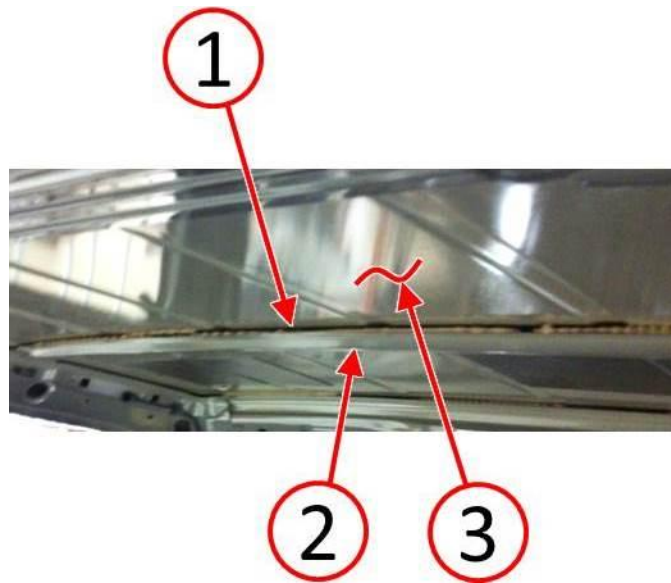
Fig. 2 Roof Bow Bonding Inspection

-
6. Inspect for missing or separated anti-flutter adhesive foam (1) between the roof bow (2) and the roof sheet metal (3) ([Fig. 2](#)).

- 1 - Missing Or Separated Foam
- 2 - Roof Bow
- 3 - Roof Sheet Metal

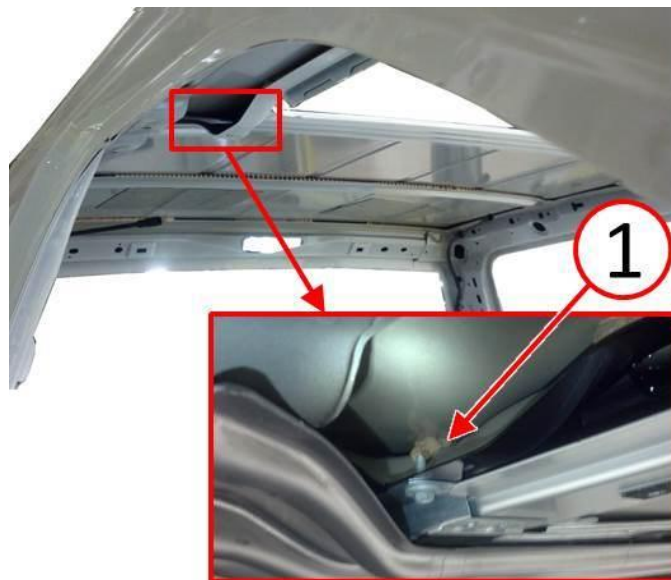
Fig. 3 Sunroof Ring Bonding Inspection

7. Inspect for missing or separated anti-flutter adhesive foam (1) between the sunroof opening reinforcement ring and the roof sheet metal in the right and left rear corners of the sunroof opening reinforcement ring (Fig. 3).

- 1 - Missing Or Separated Foam
-

8. Cover the interior components with a plastic cover before beginning the repair process.
9. Remove / scrape off the old anti-flutter adhesive foam that did not bond.

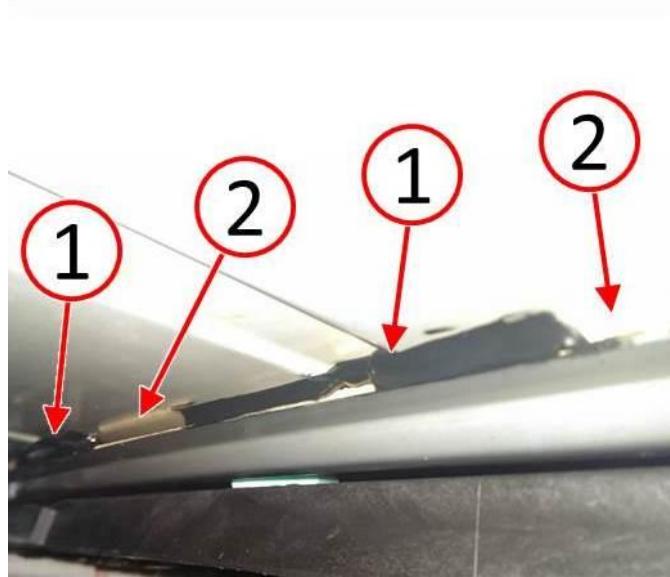
Fig. 4 Urethane Application

- 1 - Urethane Bead
2 - Intensional Gap

CAUTION: DO NOT APPLY A CONTINUOUS BEAD. Gaps in the urethane application are required to prevent distortion of the roof sheet metal panel as the urethane cures.

10. Apply windshield urethane to the missing adhesive area in several 100 mm - 125 mm (4 in. - 5 in.) beads (1) with 75 mm (3 in.) gaps (2) (Fig. 4). Remove any excess urethane.
