NUMBER: 08-028-14 REV. A

DATE: September 12, 2014

RE2 RE3 RE6 RB4 RB5 RB6 Radio Enhancements

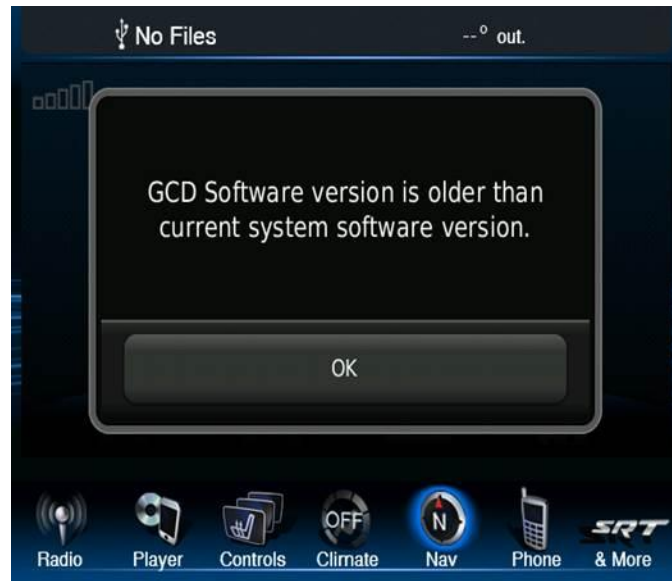
Fig. 1 Radio already has the latest software

16. Which screen does the radio display?
 - a. (Fig. 1) >>> The radio has the latest Garmin software in it, press OK and proceed to [Step #20](#).
 - b. (Fig. 2) >>> Press Yes to update the Garmin software.
17. The first step in the update is "system recover". There will be a pop up that indicates this step. This will only take a few minutes.
18. This screen will be displayed when the update is being downloaded, see ([Fig. 3](#)).

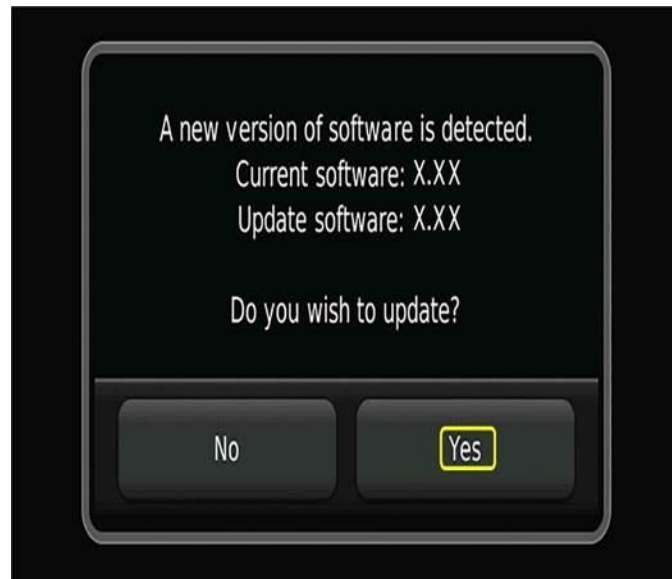
Fig. 2 Garmin software needs to be updated

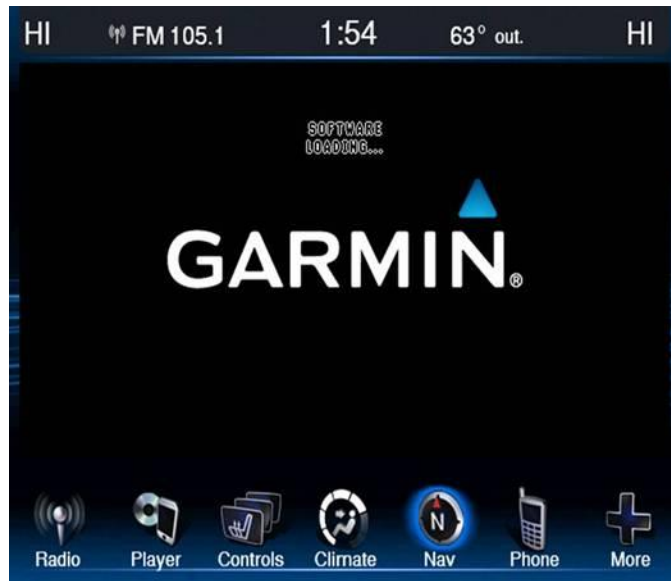
Fig. 3 This screen will be displayed next

1 - Loading software

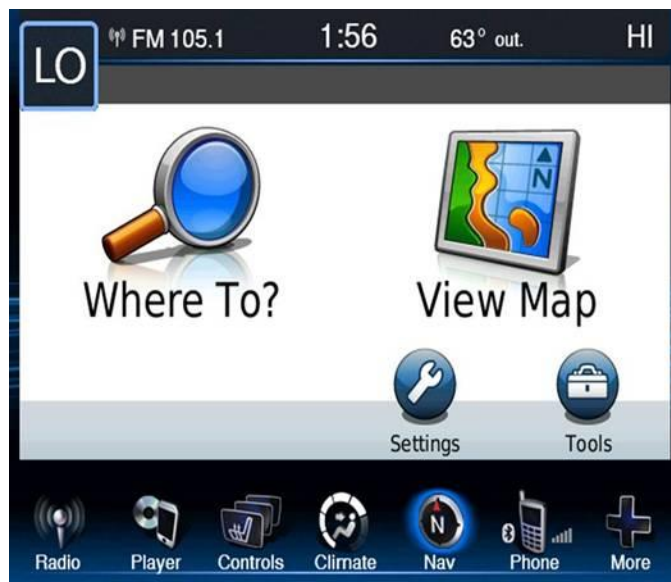
Fig. 4 Update is completed

1 - Navigation has been updated

19. When the software has completed down loading, the screen will change to the Garmin main screen, see(Fig. 4).
