NUMBER: 23-034-14 REV. A

Cowl Trim Panel Fastener Water Leak

This bulletin involves modifying or replacing the cowl trim panel fasteners to correct a water leak condition.

2007 - 2014 (JK) Jeep Wrangler

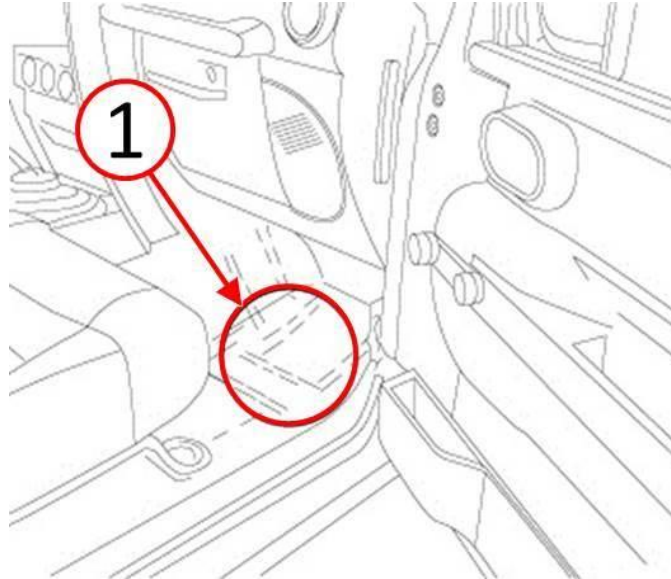
Fig. 1 Water In Foot Well

The customer may describe a water accumulation condition on the vehicle floor front foot well area.

1 - Foot Well Area

1. Determine if water in the front floor foot well is coming from the cowl side trim panel fir tree fasteners. Refer to water leak diagnosis within the detailed service procedures available in DealerCONNECT> TechCONNECT under: Service Info> 23 - Body> Diagnosis and Testing (Fig. 1).
2. Was a water leak coming from the cowl side trim panel fir tree fasteners?
 - a. YES>>> Continue with the Repair Procedure [Step #3](#).
 - b. NO>>> This Bulletin does not apply. Further diagnosis is required.

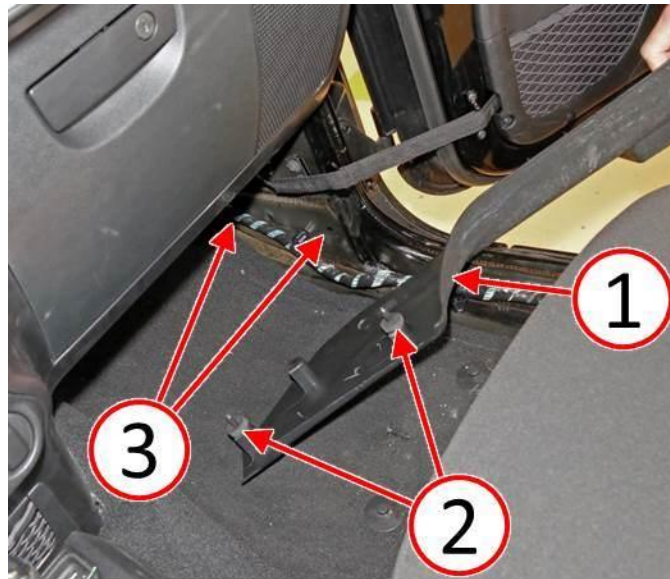
Fig. 2 Remove Cowl Trim Panel

- 1 - Cowl Trim Panel
- 2 - Fir Tree Fasteners With Foam Seal
- 3 - Cowl Trim Panel Fastener Holes

-
3. Remove the cowl trim panel (1) ([Fig. 2](#)). Refer to the detailed service procedures available in DealerCONNECT> TechCONNECT under: Service Info> 23 - Body> Interior> PANEL, Cowl Trim> Removal.
 4. Is the cowl trim panel (1) reusable and are the fir tree fasteners (2) present and in reusable condition ([Fig. 2](#))?
 - a. YES>>> Cowl trim panel and fasteners can be reused. Continue with [Step #5](#).
 - b. NO>>> Cowl trim panel and/or fasteners must be replaced. Proceed to [Step #14](#).

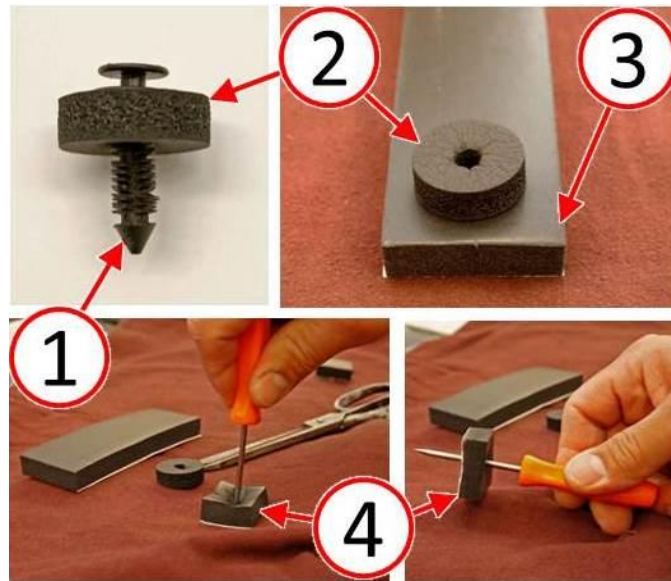
Fig. 3 Create Foam Seal

- 1 - Fir Tree Fastener
- 2 - Original Foam Seal
- 3 - Foam Material
- 4 - Created Foam Seal

-
5. Obtain one piece of foam tape (3) specified in the Parts Required section of this bulletin ([Fig. 3](#)).
 6. Remove the foam seal (2) from the fir tree fastener (1) ([Fig. 3](#)).
 7. Place the foam seal (2) on the foam tape (3) and cut a piece of the foam tape approximately the same size as the original round foam seal 32 mm (1.25 in.) ([Fig. 3](#)).

NOTE: Created foam piece can be square or round. Shape is not important as long as the overall dimension is approximately the same and not less than the original seal.

8. Pierce a **small** hole (4) through the center of the created foam seal ([Fig. 3](#)).

NOTE: Do not create a large hole. Piercing the hole with a sharp object is the preferred method to create a small hole.

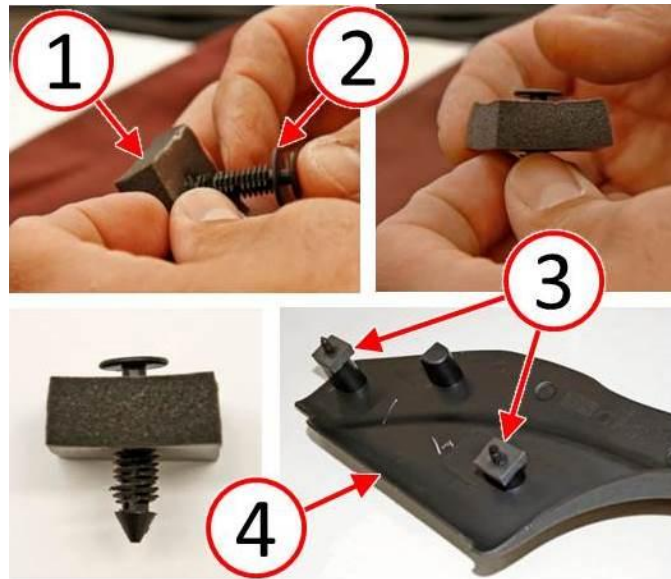
Fig. 4 Install Foam Seal

NOTE: Sticky side of the foam seal MUST face toward the fir tree fastener head. If reversed, it may create a water leak.

- 1 - Created Foam Seal
- 2 - Fir Tree Fastener
- 3 - Cowl Trim Panel
- 4 - Fir Tree Fasteners With Foam Seals

9. Install the created foam seal (1) onto the fir tree fastener (2) **with the sticky side facing toward the fir tree fastener head** (Fig. 4).

10. Install both fir tree fasteners with foam seal (3) onto the cowl trim panel (4) (Fig. 4).

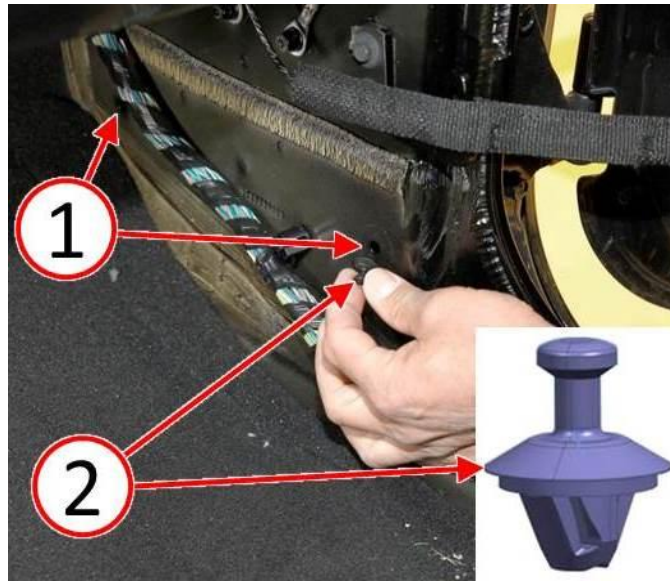
Fig. 5 Install T-Studs

- 1 - Cowl Trim Panel Fastener Holes
- 2 - Stud Clip

-
11. Install the cowl trim panel to the vehicle being very careful to align the fir tree fasteners with the fastener holes in the cowl. Misaligned fir tree fasteners will allow water to leak into the vehicle foot well. Refer to the detailed service procedures available in DealerCONNECT> TechCONNECT under: Service Info> 23 - Body> Interior> PANEL, Cowl Trim> Installation.
 12. Repeat the seal creation process for the opposite side if necessary.
 13. Verify that the water leak from the cowl side trim panel fir tree fasteners has been resolved. This completes the Repair Procedure. Do not perform the remaining steps in this procedure.
 14. Obtain a NEW cowl trim panel wiring protector cover and 2 stud clips per cowl trim panel being replaced, specified in the Parts Required section of this bulletin.
 15. Install the two stud clips (2) into the cowl trim panel fastener holes (1) (Fig. 5).

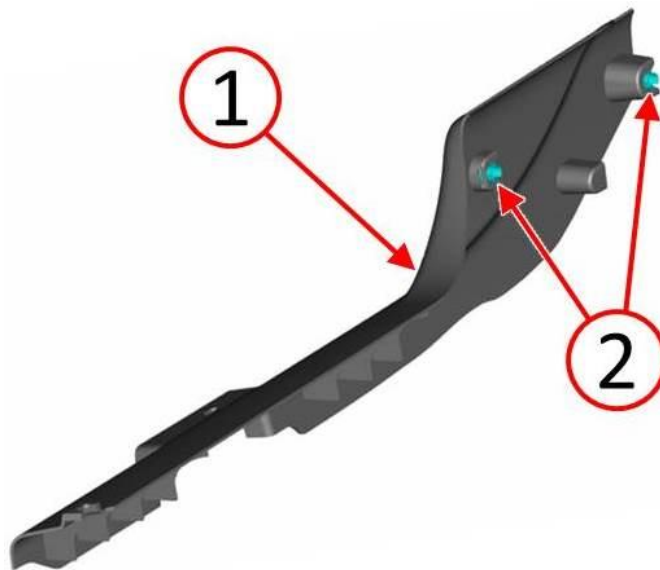
Fig. 6 Install Cowl Trim Panel

- 1 - New Cowl Trim Panel
 - 2 - Cowl Trim Panel Retainers
-

16. Install the NEW cowl trim panel (1) to the stud clips (Fig. 6). Refer to the detailed service procedures available in DealerCONNECT> TechCONNECT under: Service Info> 23 - Body> Interior> PANEL, Cowl Trim> Installation.
