NUMBER: 23-036-14

Water Leak At Hard Top Rear Seam

2015 (JK) Jeep Wrangler

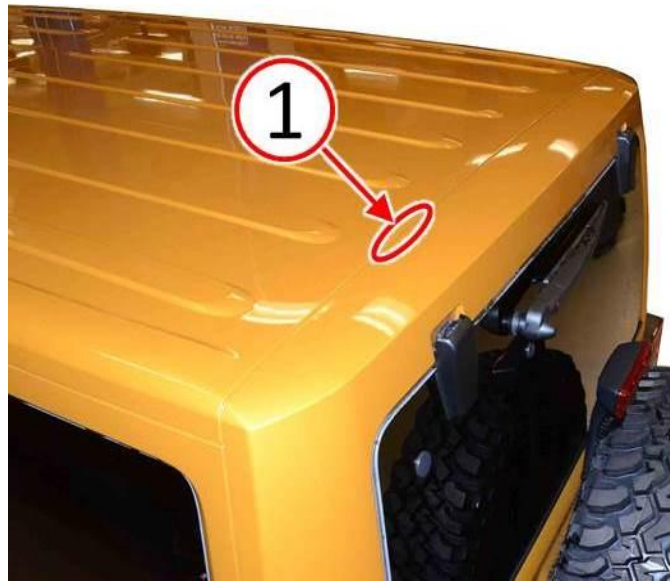
Fig. 1 Area Of Leak Concern

Water leak path through top rear bonded seam at area identified in (Fig. 1). The customer may describe water dripping from the top, running down the inside of the back glass, or running down the inside rear D-pillar.

1 - Water Leak Path At Identified Location

This bulletin involves replacing the hard top.
