TECHNICAL BULLETIN JTB00370NAS1 05 AUG 2014

Condensation on Instrument Panel Center Vent

F-TYPE (X152)

Model Year: 2014 Onwards VIN: K00001 Onwards

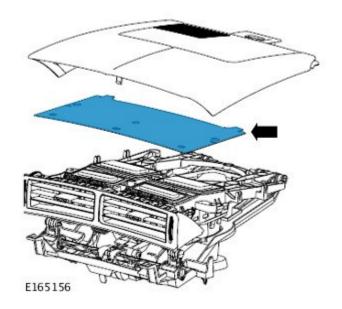
Situation: Condensation may be evident on the instrument panel center vent.

Cause: This may be caused by a difference in air/trim temperature, resulting in condensation forming on top of

the instrument panel center vent.

2. Install the foam pad to the center vent.
