TECHNICAL BULLETIN
JTB00331NAS1
04 FEB 2014

Door Adjustment Incorrect

F-TYPE (X152)

Model Year: 2014

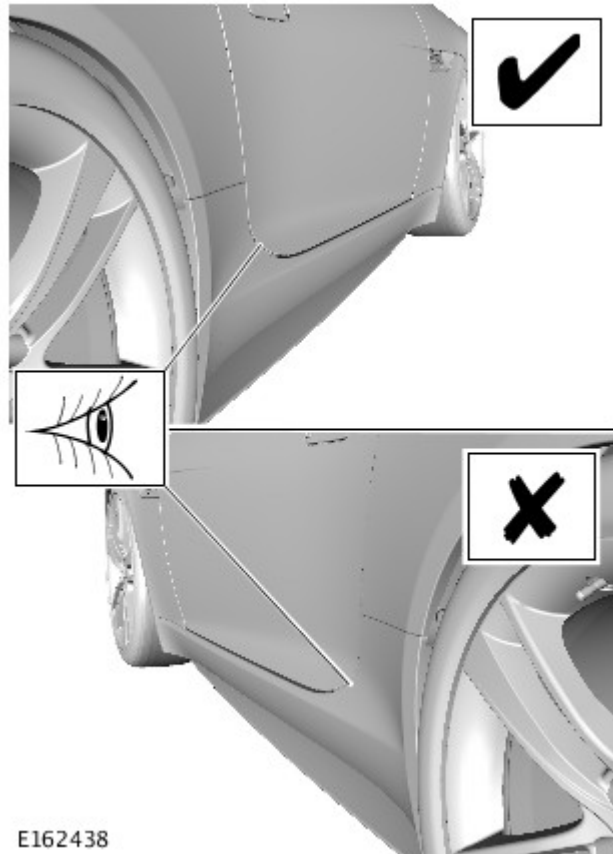
Situation: One door may appear to be out of adjustment when compared to the other door. The design intent is for both doors to sit 'proud' of the rocker panel.

Cause: This may be caused by the left door being adjusted too far inboard while the right door is adjusted to the design intent.

1. Both doors should be aligned so the door is proud of the rocker panel in the area shown.

- If the left door is not aligned proud of the rocker panel, continue to the following step(s) to adjust as necessary to match the right door.

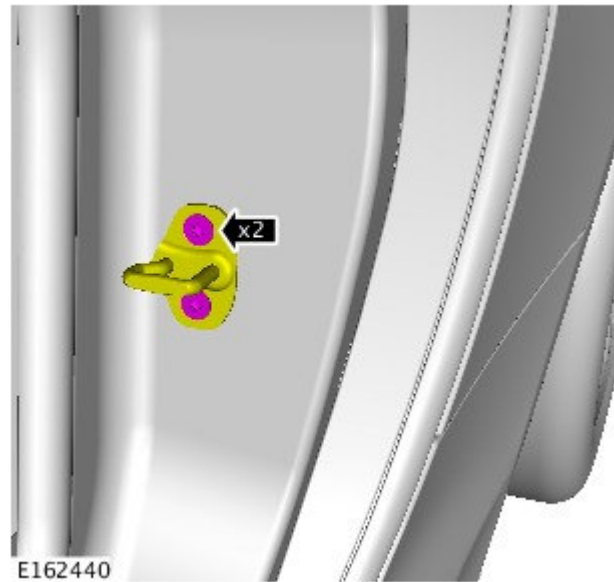
3. If the door striker drags, loosen the striker bolts; and adjust the striker as required.

- Loosen the striker bolts;
- Adjust the striker as necessary;

- Tighten the striker bolts; torque to 9Nm.

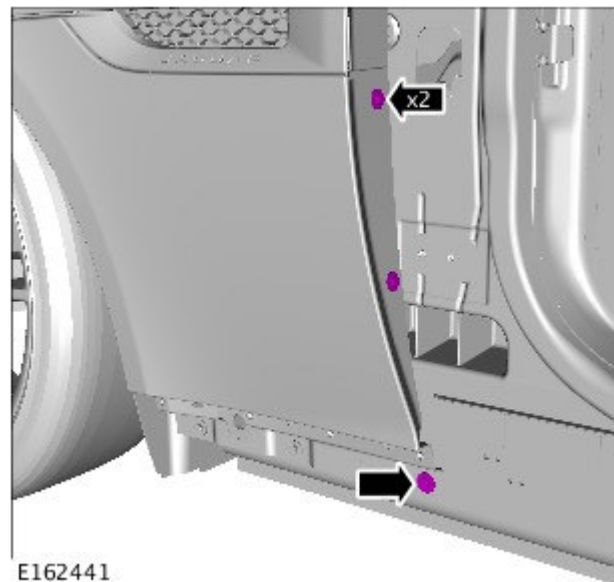
4. Check the alignment of the door to the front fender.

- If the fender requires adjustment remove the rocker panel (see TOPIx Workshop Manual section 501-08);
- Continue to the next step to adjust the door / fender alignment.

5. Loosen the two upper fender bolts.

- Remove the lower fender bolt.
