TECHNICAL BULLETIN JTB00355NAS1 13 JUN 2014

Fuel Feed Pipe 'Rattle'

XF (X250)

Model Year: 2013-2014 Engine: GTDi 2.0L Petrol

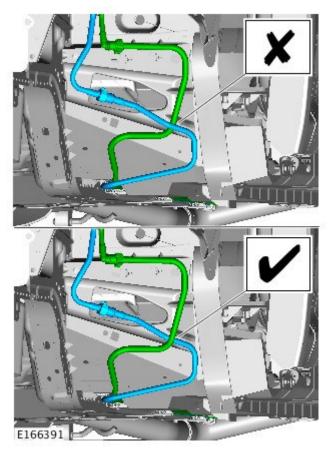
Cause: This may be caused by the fuel feed pipe touching the wheel arch liner and pushing it outwards, allowing the tire to contact the wheel arch liner.

- **5.** Re-route the hard plastic fuel line behind the braided fuel feed line.
 - Make sure the hard plastic fuel line is flush to the body panel.
