Technical Service Bulletin

37 Customer may report harsh shift concerns; no faults are stored and concern is reproducible

37 14 48 2030007/5 October 2, 2014. Supersedes Technical Service Bulletin Group 37 number 12-65 dated September 25, 2012 for reasons listed below.

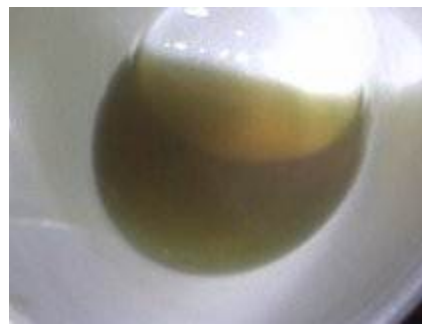
Figure 1. Fluid photograph example showing approximately one inch of fluid in the white cup, and tilted on an angle to show depth and color.

1. Perform a road test with the customer to determine if the concern can be duplicated. Pay attention to the following conditions: vehicle speed, ambient temperature, engine temperature, upshift or downshift, coasting or braking, panic stop or normal stop, and uphill or downhill drive.
2. Check the transmission oil level/condition, and correct if needed. Take a photograph of the fluid (Figure 1). Run a GFF scan to ensure that no faults are present.
