Technical Service Bulletin

01 MIL on (DTC P310B, P129F, P008B, P129E, P008A, P2540, P0087)

01 14 57 2015106/9 January 9, 2014. Supersedes Technical Service Bulletin Group 24 number 11-06 dated December 7, 2011 for reasons listed below.

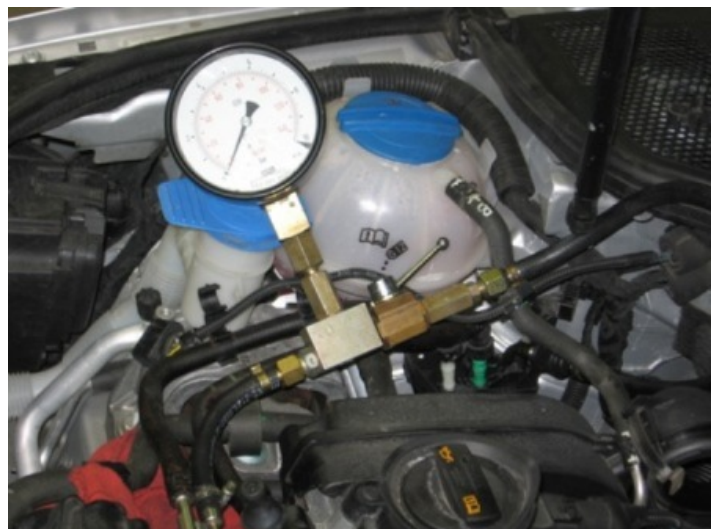
Figure 1. Measuring low-side fuel pressure with VAG 1318 gauge.

4. To calculate the adjusted gauge measurement value, add 1 bar to the value obtained from the mechanical gauge.
5. Compare the adjusted gauge measurement value to the Actual Value stored in MVB 103 field 1.
6. If the MVB 103 field 1 value deviates more than ± 1.0 bar from the adjusted gauge measurement value, then the DTC was likely triggered by a faulty G410 low-side fuel pressure sensor. Document the adjusted gauge measurement value and MVB value on the Repair Order, then perform the *Sensor replacement procedure* below.

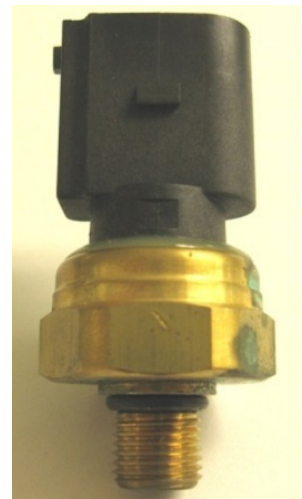
Due to fuel intrusion into the low-pressure system fuel pressure sensor (G410), a false signal may be sent to the controller, resulting in a reading that is out of tolerance.

Figure 2. Pressure sensor

1. Replace the G410 low-side fuel pressure sensor (Figure 2).

2. Clear DTCs and verify that the problem was eliminated.
3. Run Basic Settings 103 to adapt system.
4. Do not replace the high pressure fuel pump, electrical fuel pump, fuel pump control module or fuel filter unless problem persists and further diagnosis indicates a malfunction of any of these components.
