NUMBER: 08-048-14 REV. A

GROUP: Electrical

Flash: Vehicle Enhancements

****2013** - 2014 (FF) 500e**

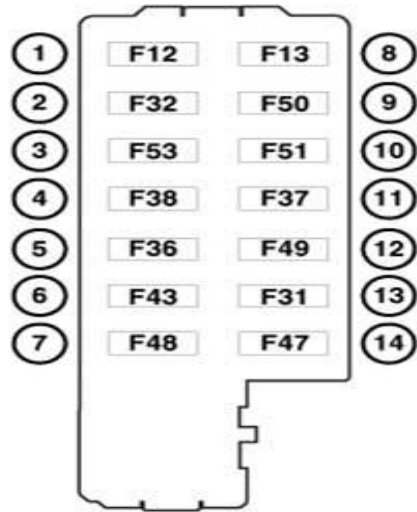
3162133

NOTE: Sometimes when updating the software on these modules, the CTM may stop communicating and/or U11F6-00 is set as an active fault. Pulling the fuse for the CTM will regain communication with that module and change U11F6-00 to a stored DTC.

Fig. 1 Interior fuse panel located by the left kick panel.

18. **Is U11F6-00 set as an active fault?
 - a. Yes >>> Proceed to [Step #19](#).
 - b. No >>> Proceed to [Step #21](#)**.
19. Turn off the ignition and pull fuse F36 for 10 seconds. It is located in the interior fuse panel, which is part of the BCM, see ([Fig. 1](#)).

Remove fuse F36 .
