**NUMBER:** 08-048-14

Flash: Vehicle Enhancements

This bulletin involves updating the software in multiple modules, Vehicle Tracking Module (VTM), Body Control Module (BCM), On-Board Charging Module (OBCM), Power Inverter Module (PIM), Battery Pack Control Module (BPCM) and Electric Vehicle Control Unit (EVCU) if required.

2014 (FF) 500e

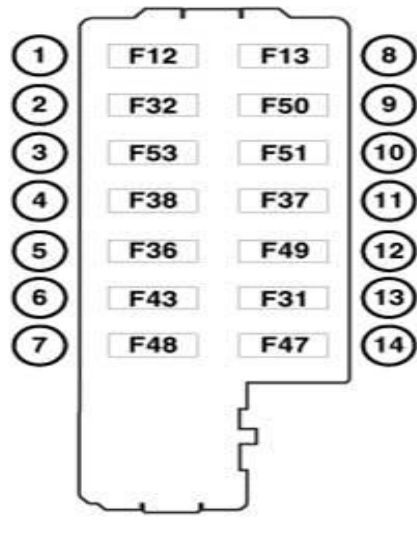
**NOTE: Sometimes when updating these modules, the CTM may stop communicating and/or U11F6-00 is set as an active fault. Pulling the fuse for the CTM will regain communication with that module and change U11F6-00 to a stored DTC.**

**Fig. 1 Interior fuse panel located by the left kick panel.**

10. Turn off the ignition and pull fuse F36 for 10 seconds. It is located in the interior fuse panel, which is part of the BCM, see ([Fig. 1](#)).

Remove fuses F36 and F51.
