NUMBER: 09-001-14

Hard Contact Knocking Noise In Engine Compartment Primarily While Turning Left

2011-2014 JC Journey

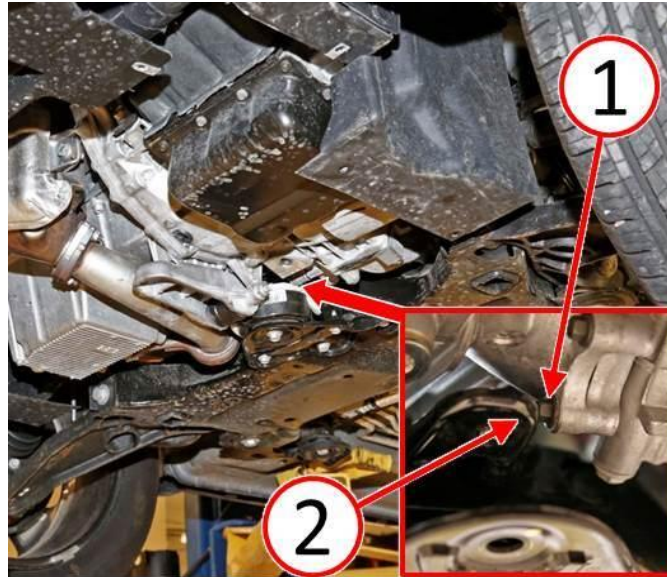
Fig. 2 Area Of Contact Concern

Hard contact knocking noise in the engine compartment caused by contact between the Rear Engine Mount Bracket and the fastener on the Power Transfer Unit (PTU). Noise heard primarily while turning left.

3. Inspect for evidence of contact between the Rear Engine Mount Bracket (2) and the fastener (1) on the PTU (Fig. 2). Is evidence of contact observed?
 - a. YES, contact is observed.>>> Continue with [Step #4](#).
 - b. NO, contact is NOT observed.>>> Continue with further diagnosis. This bulletin does not apply.

-
4. Replace the Rear Engine Mount Bracket. Refer to the detailed repair procedures available in: DealerCONNECT> TechCONNECT under: Service Info> 09 - Engine, 2.0L Diesel> Engine Mounting> BRACKET, Engine Mount, Rear Mount> Removal/Installation.
