NUMBER: 18-028-14 REV. B

Flash: MIL Illumination - Diagnostic and System Improvements

2014 (DS) Ram Pickup (1500)

NOTE: This bulletin applies to vehicles equipped with a 3.0L diesel engine (sales code EXF) built on or before September 08, 2014 (MDH 0908XX).

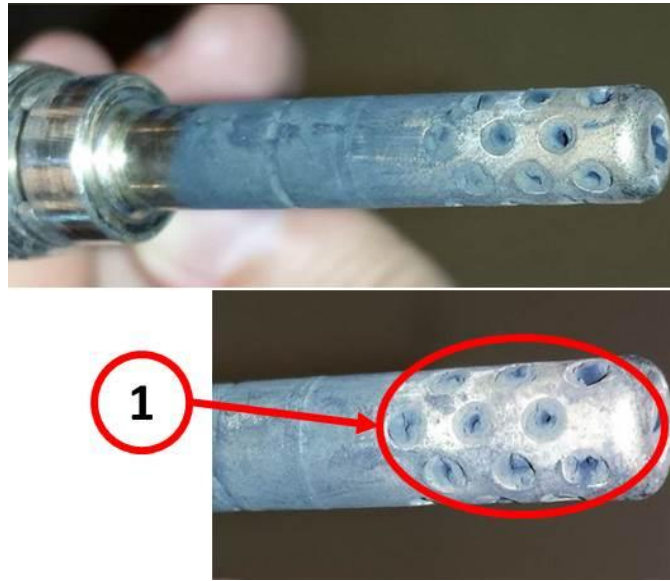
Fig. 1 EGT Sensor Bank 1 Sensor 2

10. ****Inspect the sensor body and probe for any signs of damage or excessive soot.****
Refer to (Fig. 1).

1 - Excessive soot blocking sensor ports.

-
11. Was excessive soot found on the sensor?
 a. Yes>>> Proceed to [Step #12](#).
 b. No>>> Proceed to [Step #13](#).
12. ****Using shop air set to a maximum of 80 psi, clean all excessive soot from the sensor probe.****

13. **** Using a suitable multi-meter with appropriate test probes, test the resistance between the sensor connector terminals 1 and 2. With the sensor at room temperature, 65-75 °F (18-25 °C), the resistance should measure between 200 and 240 ohms.****

14. ****Is the temperature sensor resistance within specifications?**
 a. Yes>>> Install the original EGT sensor 1/2. Refer to detailed installation procedures available in DealerCONNECT> TechCONNECT> Service Info Section 11 - Exhaust System> Sensor, Exhaust Temperature> Installation> Exhaust Gas Temperature Sensor 1/2.

b. No>>> Install a new EGT sensor 1/2. Refer to detailed installation procedures available in DealerCONNECT> TechCONNECT> Service Info Section 11 - Exhaust System> Sensor, Exhaust Temperature> Installation> Exhaust Gas Temperature Sensor 1/2.**
