NUMBER: 18-054-14

DATE: October 08, 2014

Intermittent Extended Crank, Long Crank Time.

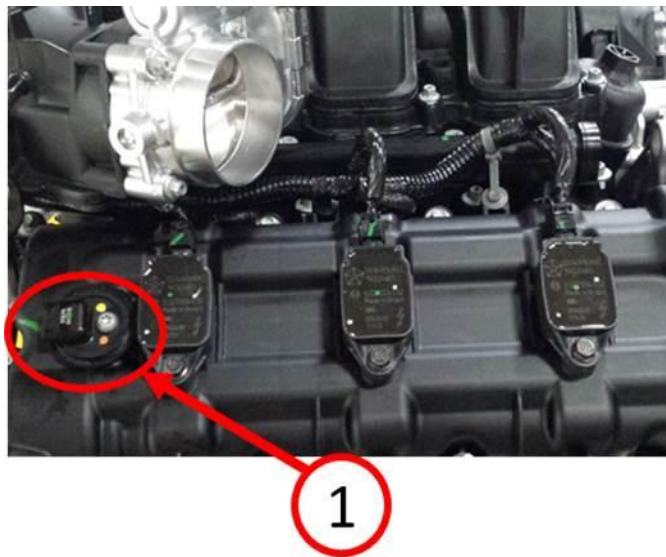
Fig. 1 Camshaft Position Sensor Location

1. Open the hood and remove the engine cover.
2. Locate the Bank 1 Camshaft Position Sensor located in the top rear of the valve cover. See (Fig. 1).

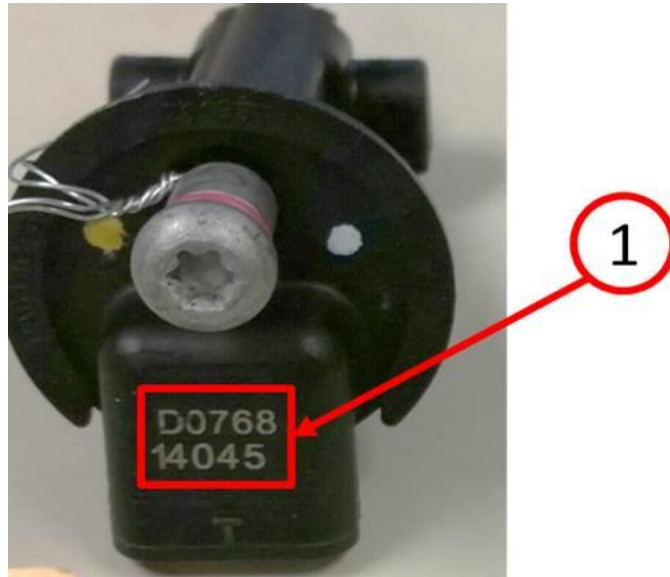
Fig. 2 Camshaft Position Sensor

3. Inspect and record the serial number stamped on the top of the sensor. See (Fig. 2).

4. Does the serial number begin with the letter "D"?
 - a. Yes>>> Replace the camshaft position sensor per published service procedures in Tech Connect Service Information Section 08 - Electrical>8I - Ignition Control>Sensor, Camshaft Position>Removal/Installation, and proceed to .
 - b. No>>> This bulletin does not apply. Further diagnostics are required.
5. Using WiTECH perform the Cam/Crank Variation Relearn procedure and follow the on screen instructions.
6. The bulletin is now complete.
