VW Elsa Newsletter

Edition 99: August 18, 2014

66-14-01 Replacing the Side Spoilers (Flaps) 2015 GTI

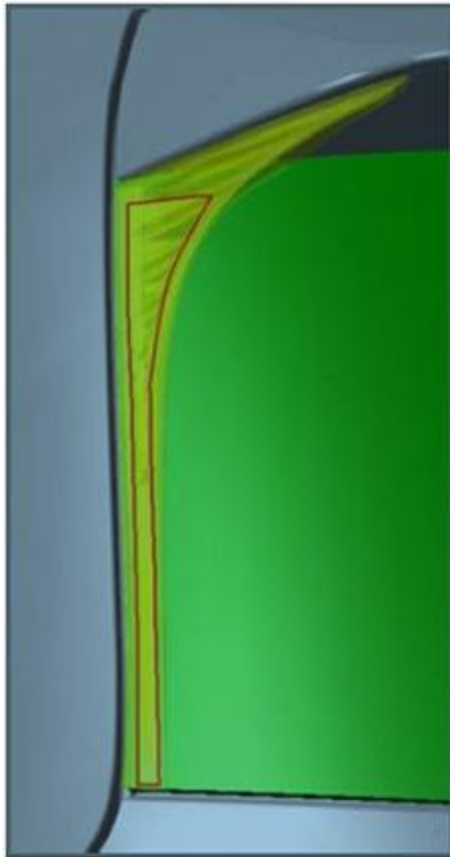
Figure 1: Primed area in yellow

1. Remove the spoilers (flaps) following the steps in the ELSA repair manual: **Body → 66 Exterior equipment → Spoiler → Removing and installing side spoiler.**
2. Remove the (tape) residue from the windshield and clean it thoroughly with **cleaning solution D 009.401.04***.
3. Using a dry microfiber cloth, wipe the window dry and wait **5 minutes** before proceeding with the next step.
4. Apply **one** layer of glass primer (**D 177.500.A1****), apply the primer in **one direction** only (Figure 1 and 2).

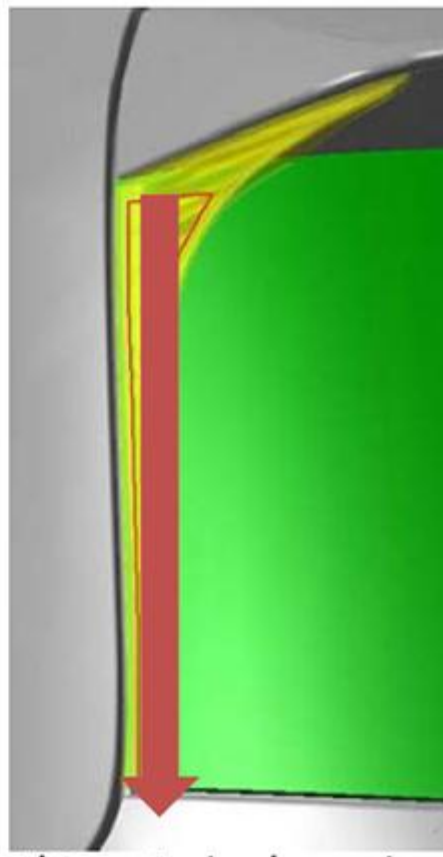
Figure 2: Apply primer and wipe in one direction

5. Directly after applying the primer, use a microfiber cloth to wipe off the primed surface in one swipe as shown in Figure 2 (**wipe in one direction only**).
6. Again wait **5 minutes** before proceeding to the next step.
