# Audi Elsa Newsletter

Edition 88: June 2, 2014

## PDI – Additional Spring (bump stop) Installation

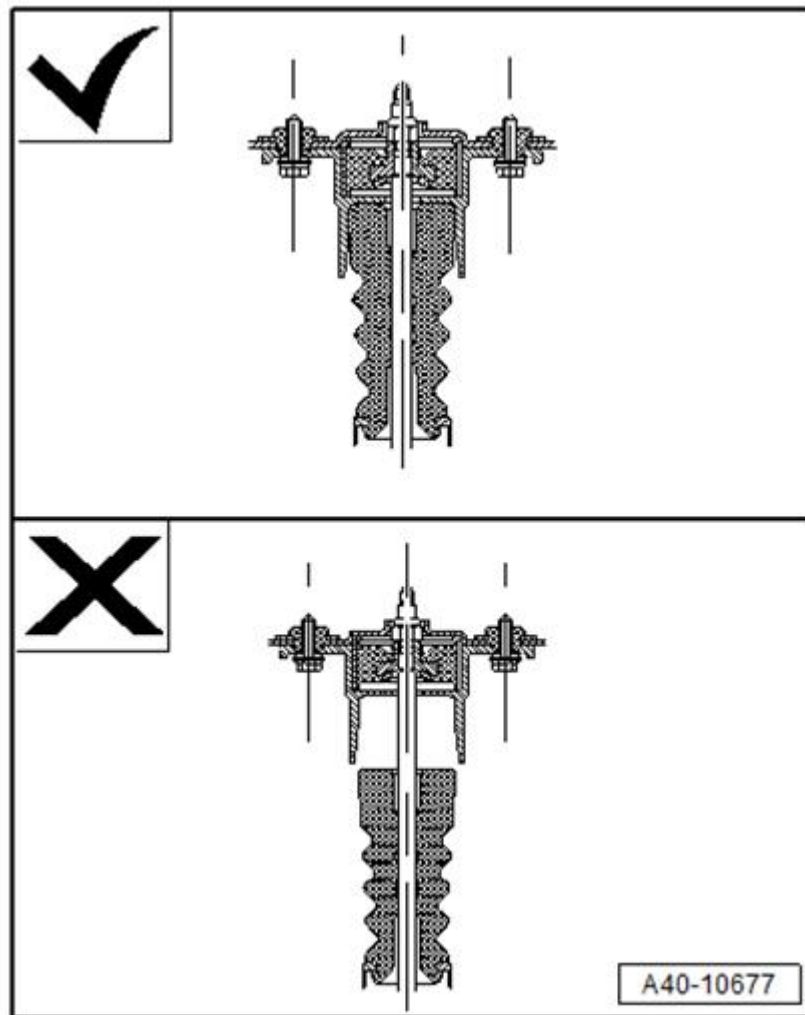
### Auxiliary Strut, Installing

It is critical that the bump stops are fully seated during the PDI process and prior to customer delivery. If this step is not completed correctly, there is a good potential

that the vehicle will return for a repair.

- Assembly Paste -G 052 109 A2-
  - Clean the loose auxiliary strut upper edge of rough deposits and coat with assembly paste G 052 109 A2.
  - Push the auxiliary strut by hand securely in the shock absorber mount.
