Audi Elsa Newsletter

Edition 84: May 5, 2014

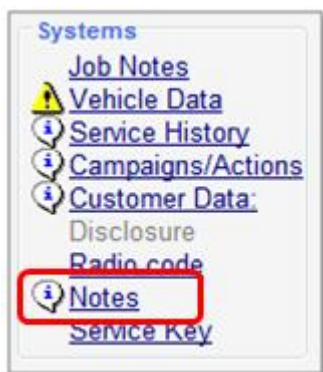
1. On the Systems menu, click "Notes". A pop-up will display with a list of relevant documents:

We are currently having issues with the displayed list of documents when selecting "Notes" from the Systems menu (location 1, above).

The list may include erroneous items or broken links.

In the mean time we encourage everyone to **use the "Vehicle-specific service information" location (location 2, above) to access RA/PSS information.**
