Audi Elsa Newsletter

Edition 87: May 26, 2014

PDI – Additional Spring (bump stop) Installation

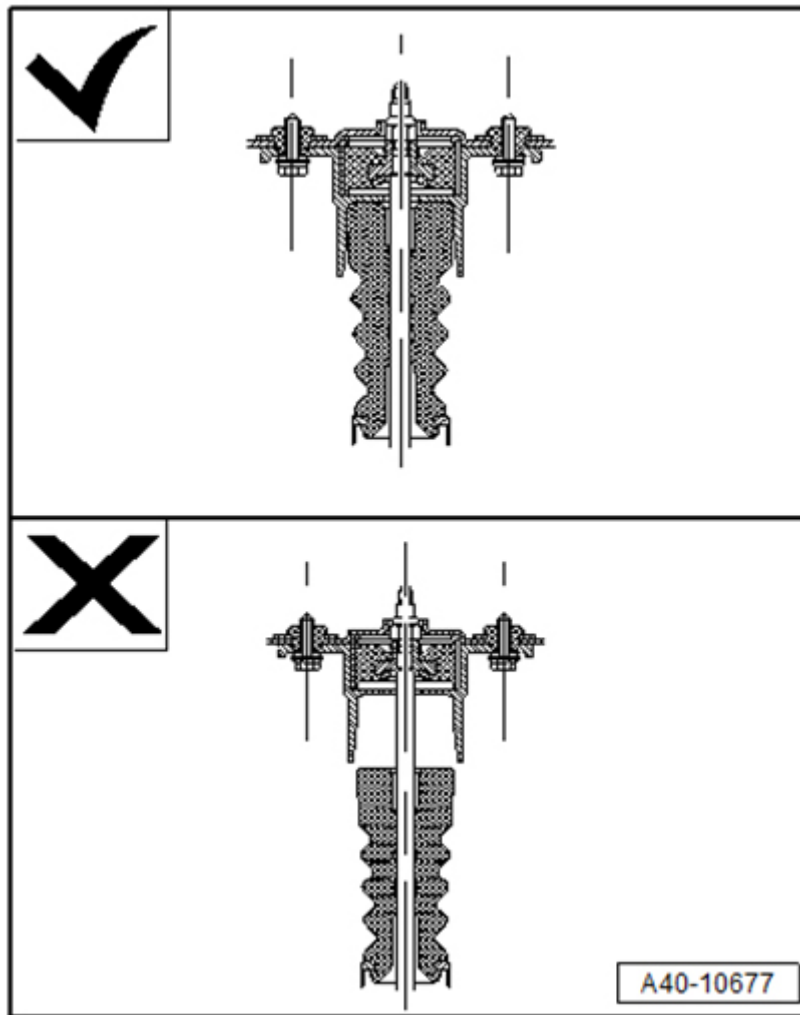
Auxiliary Strut, Installing

It is critical that the bump stops are fully seated during the PDI process and prior to customer delivery. If this step is not completed correctly, there is a good potential that the vehicle will return for a repair.

- Assembly Paste -G 052 109 A2-
- Clean the loose auxiliary strut upper edge of rough deposits and coat with assembly paste G 052 109 A2.
- Push the auxiliary strut by hand securely in the shock absorber mount.
