**NUMBER:** 21-037-14

**DATE:** November 12, 2014

66RFE Transmission Slip Under High Engine Load And Premature Wear

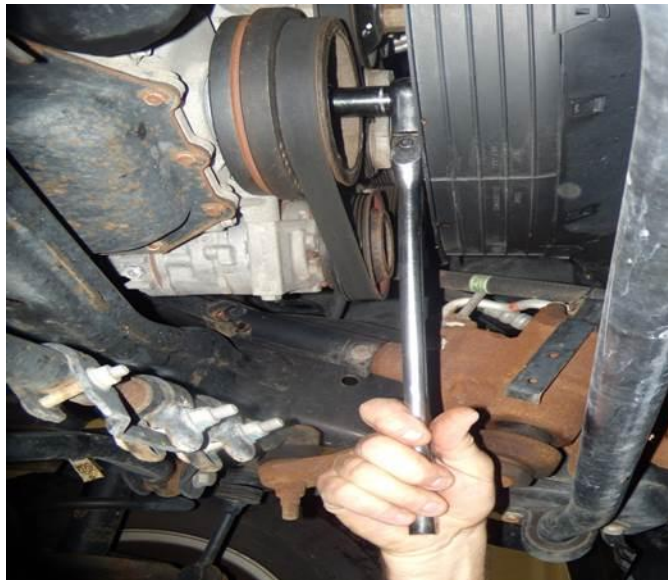
**Fig. 1 Engine Rotation**

1. Disconnect and isolate the negative battery cable.
2. Raise and support the vehicle on a suitable hoist. Refer to the detailed service procedures in DealerCONNECT/techCONNECT Service Info section 04 - Vehicle Quick Reference> Hoisting> Standard Procedure.
3. Remove the starter to gain access to the inside of the bell housing. Refer to detailed service procedures in DealerCONNECT/techCONNECT Service Info section 08 - Electrical> 8F - Engine Systems> Starting> Starter> Removal/Installation.
4. Using a suitable socket and ratchet, rotate the engine clockwise until the bar code label on the torque converter is visible via inspection mirror. If necessary, mark the torque converter using an appropriate marker to ensure full engine rotation has been achieved. Refer to (Fig. 1) and (Fig. 2).

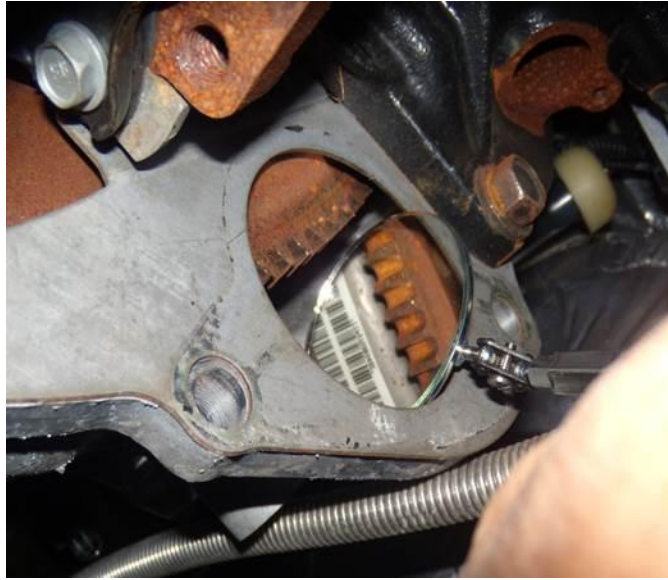
**Fig. 2 Torque Converter Label Inspection**

**NOTE: Only the first 7 digits on the bar code serial number will be used to determine replacement. If the bar code is missing then the torque converter is to be considered suspect and should be replaced.**

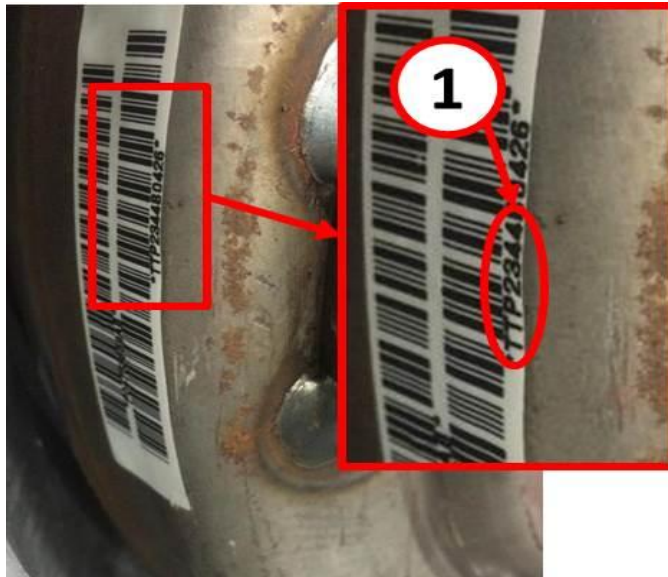
**Fig. 3 Torque Converter Label**

5. Record the serial number beginning with TTP. See (Fig. 3).

1 - Torque Converter Build Date

6. Does the torque converter serial number fall between TTP2544xxxxx and TTP2734xxxxx?
- Yes>>> Replace the torque converter. Refer to detailed service procedures in DealerCONNECT/techCONNECT Service Info section 21- Transmission and Transfer Case> Automatic - 66RFE> TORQUE CONVERTER> Removal/Installation.
  - No>>> No further repairs are necessary. Use LOP 21-00-22-90 to close out the RRT portion of this service bulletin.
