NUMBER: 23-034-14

Cowl Trim Panel Fastener Water Leak

2007 - 2014 (JK) Jeep Wrangler

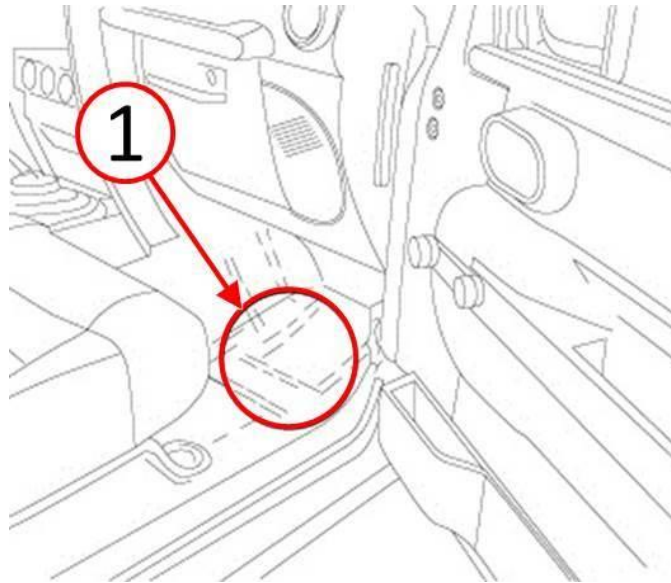
Fig. 1 Water In Foot Well

The customer may describe a water accumulation condition on the vehicle floor front foot well area.

1 - Foot Well Area

1. Determine if water in the front floor foot well is coming from the cowl side trim panel fir tree fasteners. Refer to water leak diagnosis within the detailed service procedures available in DealerCONNECT> TechCONNECT under: Service Info> 23 - Body> Diagnosis and Testing (Fig. 1).
2. Was a water leak coming from the cowl side trim panel fir tree fasteners?

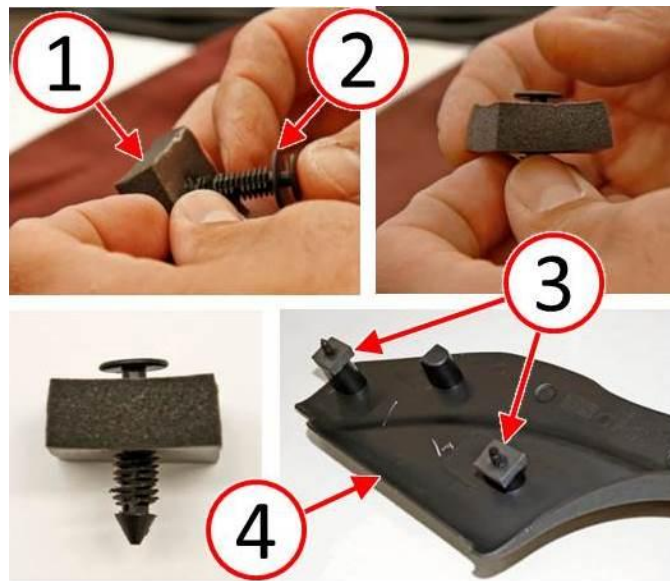
Fig. 4 Install Foam Seal

NOTE: Sticky side of the foam seal MUST face toward the fir tree fastener head. If reversed, it may create a water leak.

- 1 - Created Foam Seal
- 2 - Fir Tree Fastener
- 3 - Cowl Trim Panel
- 4 - Fir Tree Fasteners With Foam Seals

9. Install the created foam seal (1) onto the fir tree fastener (2) **with the sticky side facing toward the fir tree fastener head** (Fig. 4).

10. Install both fir tree fasteners with foam seal (3) onto the cowl trim panel (4) (Fig. 4).

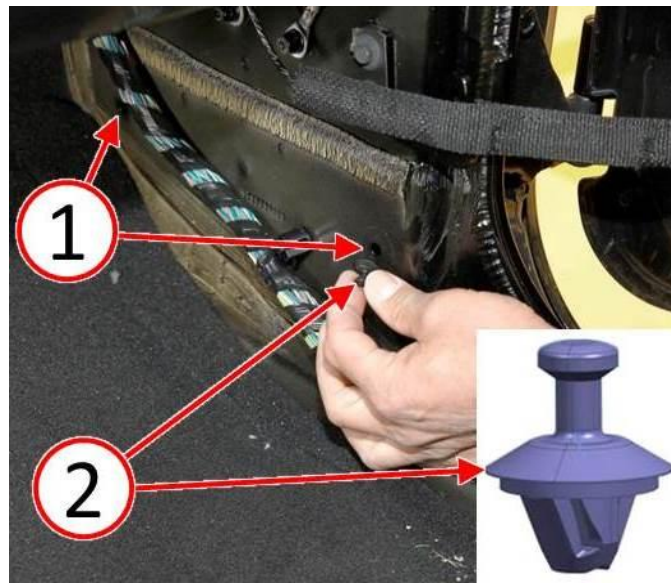
Fig. 5 Install T-Studs

- 1 - Cowl Trim Panel Fastener Holes
- 2 - Stud Clip

-
11. Install the cowl trim panel to the vehicle being very careful to align the fir tree fasteners with the fastener holes in the cowl. Misaligned fir tree fasteners will allow water to leak into the vehicle foot well. Refer to the detailed service procedures available in DealerCONNECT> TechCONNECT under: Service Info> 23 - Body> Interior> PANEL, Cowl Trim> Installation.
 12. Repeat the seal creation process for the opposite side if necessary.
 13. Verify that the water leak from the cowl side trim panel fir tree fasteners has been resolved. This completes the Repair Procedure. Do not perform the remaining steps in this procedure.
 14. Obtain a NEW cowl trim panel wiring protector cover and 2 stud clips per cowl trim panel being replaced, specified in the Parts Required section of this bulletin.
 15. Install the two stud clips (2) into the cowl trim panel fastener holes (1) (Fig. 5).
