ARTICLES CONTAINED IN THIS ISSUE

CODE	ARTICLE.....	PAGE
(00)	May STIS New Releases	05
(01)	QMR of the Month.....	01
(01)	2015MY Legacy and Outback Transit Fuse Information	04
(02)	Too Much Oil In The Engine Revisited	02
(12)	Whitish Discoloration / Deposits on Front Door Panels, 2012MY and Later Impreza and XV Crosstrek® Models.....	03

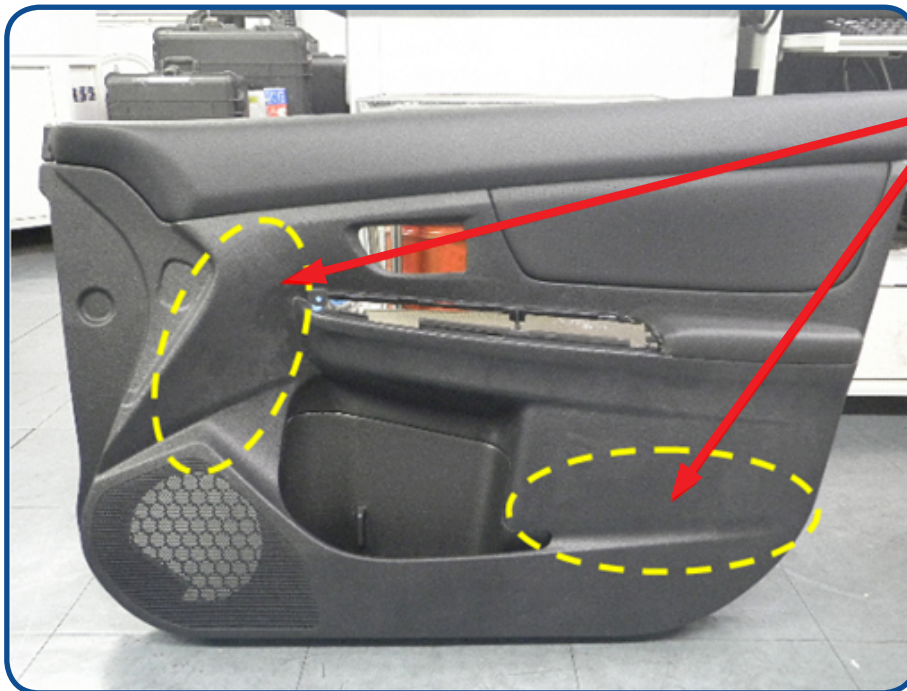
If you receive a customer concern of a whitish discoloration found on the front interior door trim panels, it is most likely a by-product of the scratch prevention agent used in the front door trim material. If the vehicle has been in storage for a period of time or unused with all the windows closed, a lack of air circulation in the cabin can cause deposits to form on the front door trim panel surfaces in the areas shown in the photo below.

Common Areas For The Whitish Deposits To Accumulate.

Use a clean detailing cloth wet with plain water to remove the deposits. After the surface dries, confirm all the deposits have been removed. Should any deposits remain, repeat the process again. Make sure the cloth is wet as using a dry cloth can damage the surface of the trim panel.

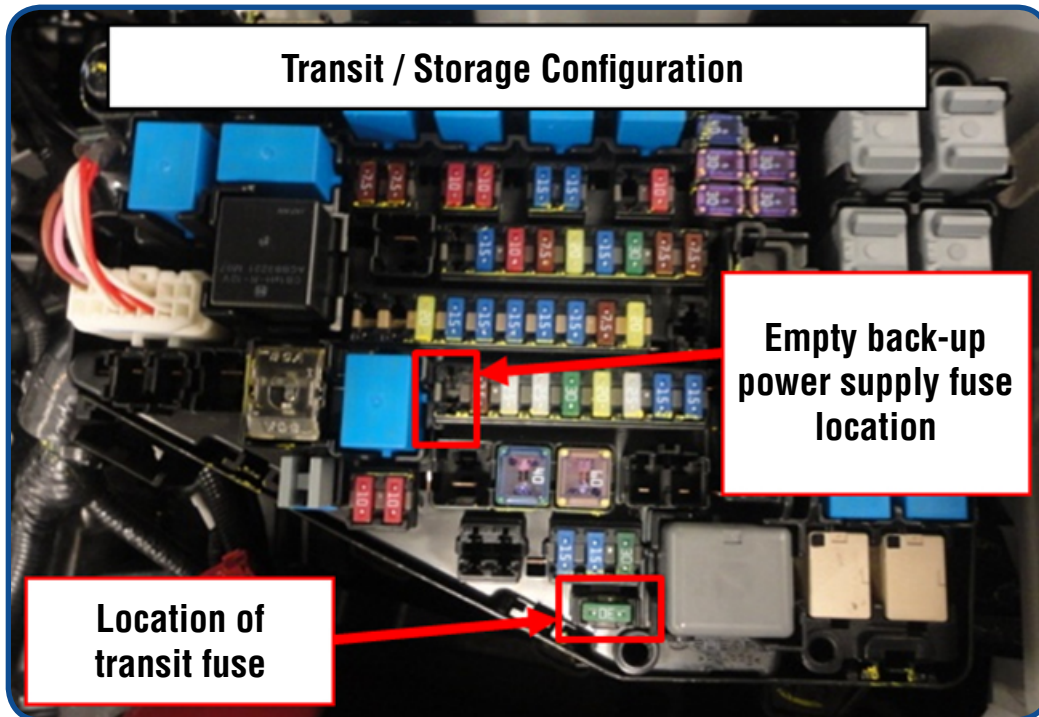
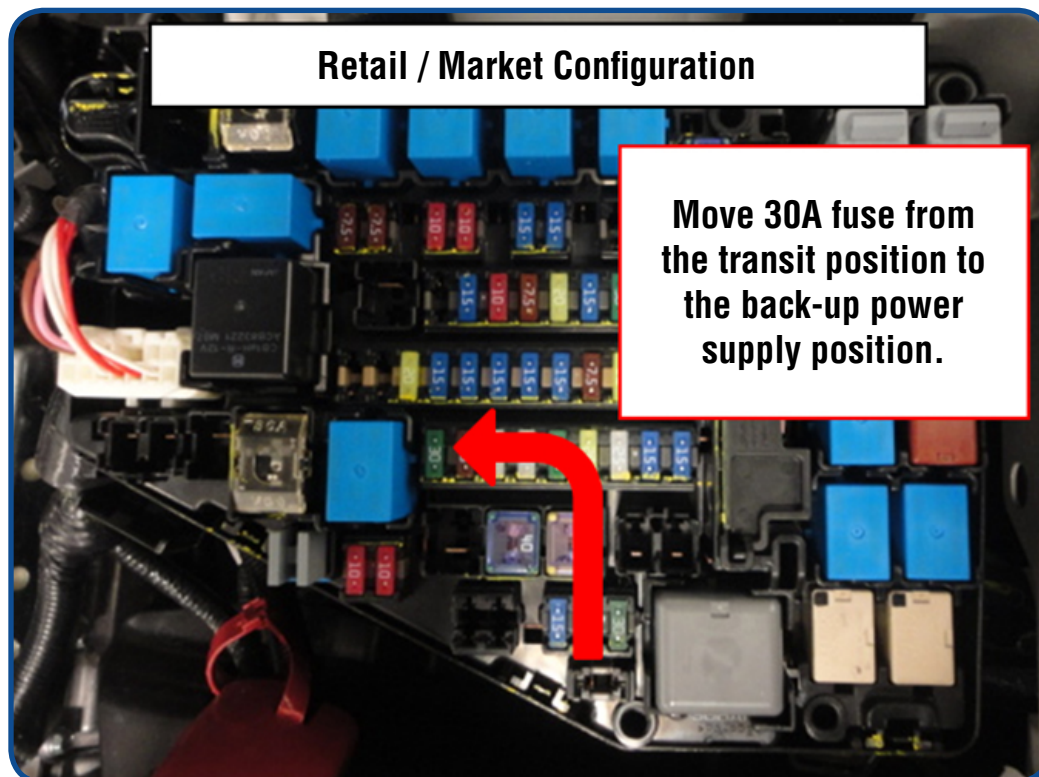
In the very near future, your dealership will start to receive the first shipments of the all-new 2015MY Legacy and Outback models. As part of the Pre-Delivery Inspection procedure, the transit fuse will need to be relocated to the back-up power fuse location in the Main Fuse Box (M/B), under the hood as shown in the illustrations below.
