**SERVICE BULLETIN**

**APPLICABILITY:** 2014MY XV Crosstrek Hybrid (HEV)

**NUMBER:** 07-81-14

**SUBJECT:** Revised Rear Combination Lamp to Prevent Condensation

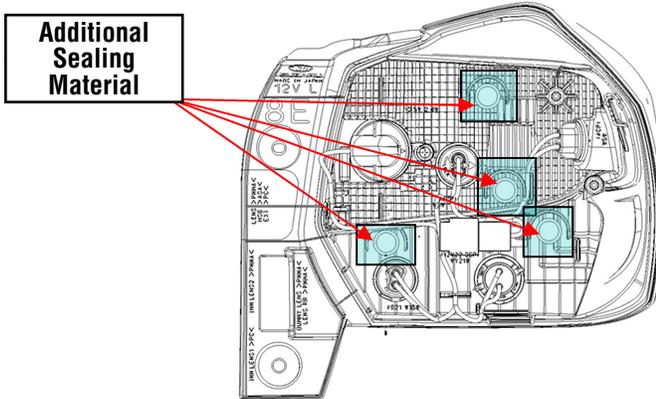
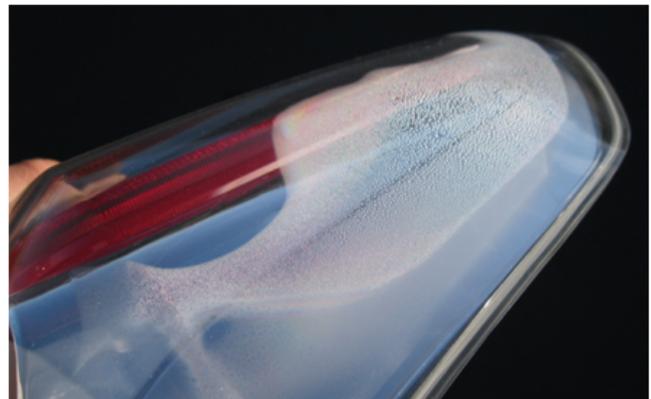
A revised rear combination lamp assembly has been developed which utilizes additional sealing material in four areas designed to prevent condensation from occurring on the inside of the housing. When performing this procedure, replace BOTH rear combination lamps at the same time.
