SERVICE BULLETIN

APPLICABILITY: 2008MY and Later Impreza, WRX and STI
2009MY and Later Forester M/T Equipped Vehicles
with Hill Start Assist

NUMBER: 03-72-14

SUBJECT: Hill Start Assist (HSA) Warning Light, DTC C0076

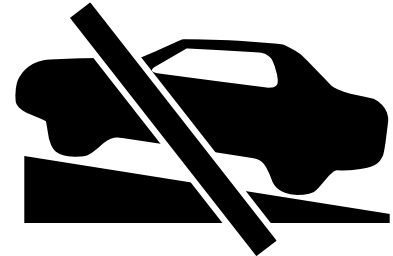
This bulletin provides information to address a customer concern of intermittent operation of the Hill Start Assist warning lamp. When the HSA warning lamp is illuminated, the hill start assist system is inoperative. DTC C0076 may be stored in memory along with detail codes 2610H and / or 2620H. All of these codes refer to the operation of the clutch switches.
