SERVICE BULLETIN

APPLICABILITY: 2013MY XV Crosstrek
2012MY-2013MY Impreza 2.0L Models

SUBJECT: “Reed-Type” Wind Sound from Front Windshield Molding

NUMBER: 12-155-13R
DATE: 10/03/13
REVISED: 02/28/14

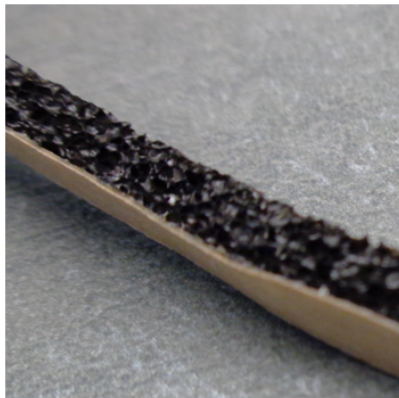
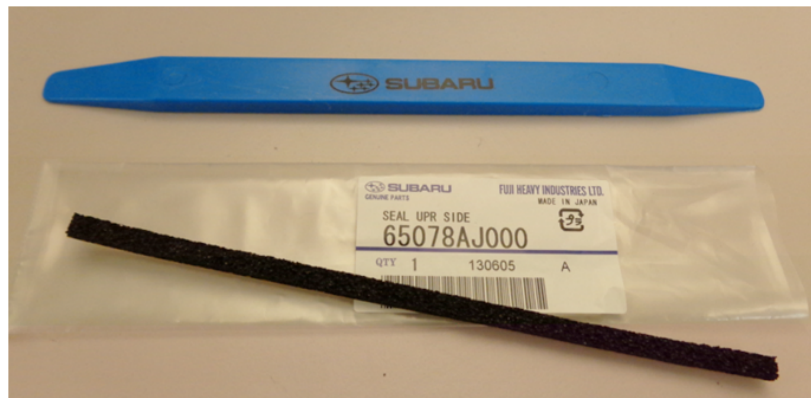
The photos below show the EPDM foam strip and for a size reference, a plastic trim tool which will be used to help lift the seal lip and gain access to the body gap where the foam strip will be installed.

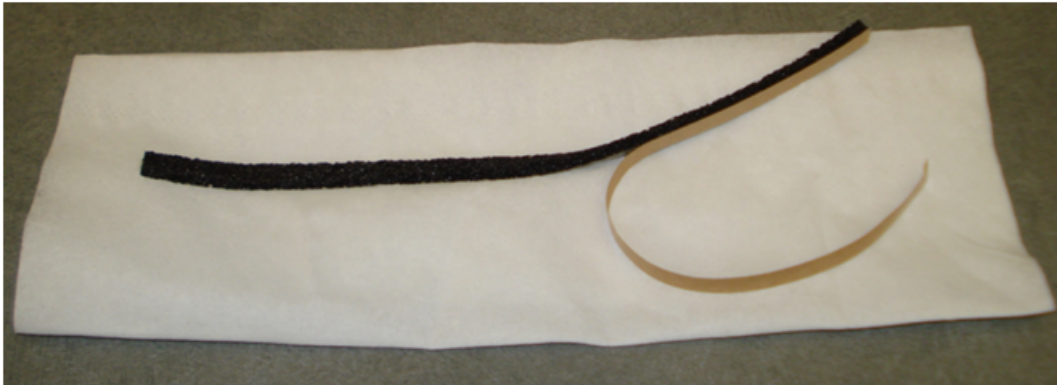
Peeling the backing and sticking the foam to a tissue

The foam strip has a backing which must be removed to expose its adhesive. The adhesive must be “neutralized” by sticking it to a facial tissue (or equivalent) then peeling it off before beginning the installation otherwise it will stick to the vehicle body or the weatherstrip.

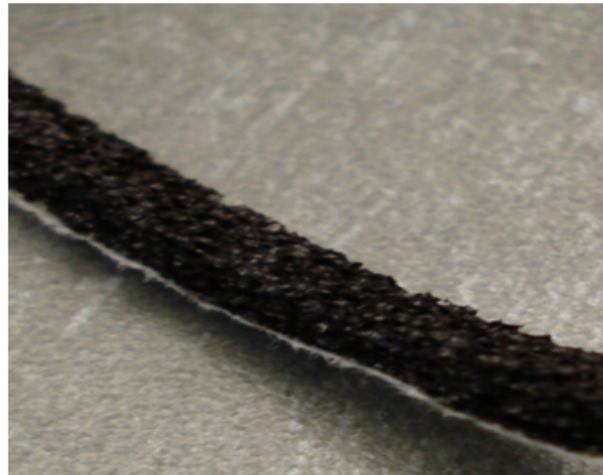
Foam after removing it from the tissue and pulling off the excess paper
