### ARTICLES CONTAINED IN THIS ISSUE

CODE	ARTICLE.....	PAGE
(01)	QMR of the Month.....	01
(01)	Authorization Request (AR) for Paint and Glass over \$500.00 ..	02
(01)	2014 XV Crosstrek Hybrid Launch - Your help is Needed .....	05
(02)	FA and FB Engine Connecting Rod Bolt Removal TIPS .....	03
(07)	Operation of SI-Drive, Sport Sharp (S#) Mode after Cold Start.....	01
(07)	Midtronics GR8 Use During Control Unit Reprogramming ..	06
(16)	CVT Torque Converters .....	04

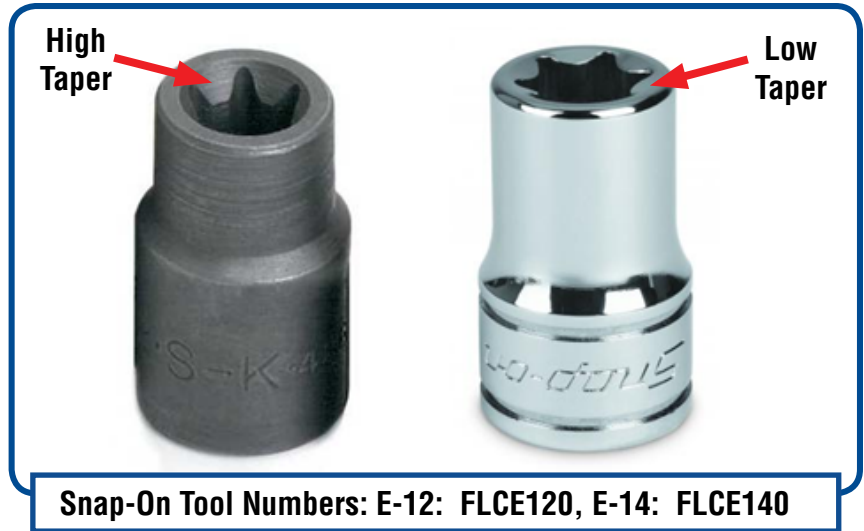
The Techline occasionally receives calls from Technicians having difficulty removing connecting rod bolts. The **one-time use** connecting rod bolts used in FA and FB engines require a female Torx® socket for their removal, size E-12, (listed in the Service Manual as special tool P.N. 18270AA010) or size E-14, (18270AA020) depending on the application. Because of the ready availability of less expensive common shop tools, these special tool sockets were not shipped to dealers. See your local tool dealer for assistance in locating one of each size of these special sockets. As shown in the photos above, there are differences in the “taper” areas of these sockets. Be sure to specify that you need a “low taper” or shallow counter-sunk socket for this application.

To reduce the possibility of damage or stripping of the bolt head and to get the most engagement of the socket onto the fastener, our recommendation is to only use the “low” taper socket as shown on the right. In addition, always confirm an E-12 socket is being used on an E-12 bolt. Although an E-14 socket will fit onto an E-12 bolt, it will round-off the fastener and could make it impossible to use an E-12 socket afterward. The following is not recommended as permanent solution. Use of the correct tool for the job is always preferred. If all you have available is a “high” taper version, until a new low taper socket can be secured, **carefully** grind it as necessary to remove the excess tapered portion and “convert” it to a low taper tool. **Take your time** (always wear eye protection!) and be careful to not excessively overheat the socket while grinding which will likely change the hardness characteristics (temper) of the socket material and soften it.

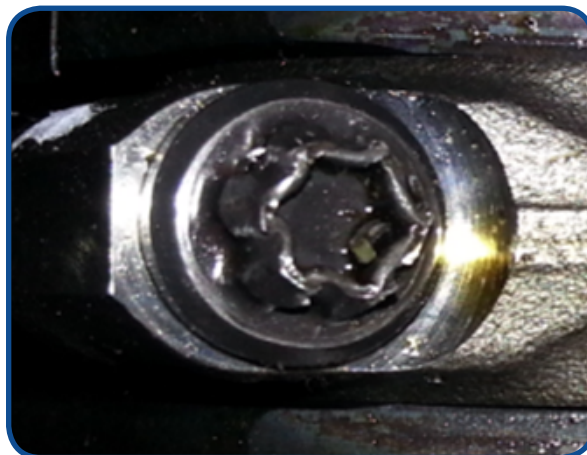
- NEVER use an impact tool to loosen the connecting rod bolts. **Use hand tools only.**
- Always make sure the socket you are using is fully seated “square” on the fastener and not at an angle which could cause the fastener to round off as shown below.

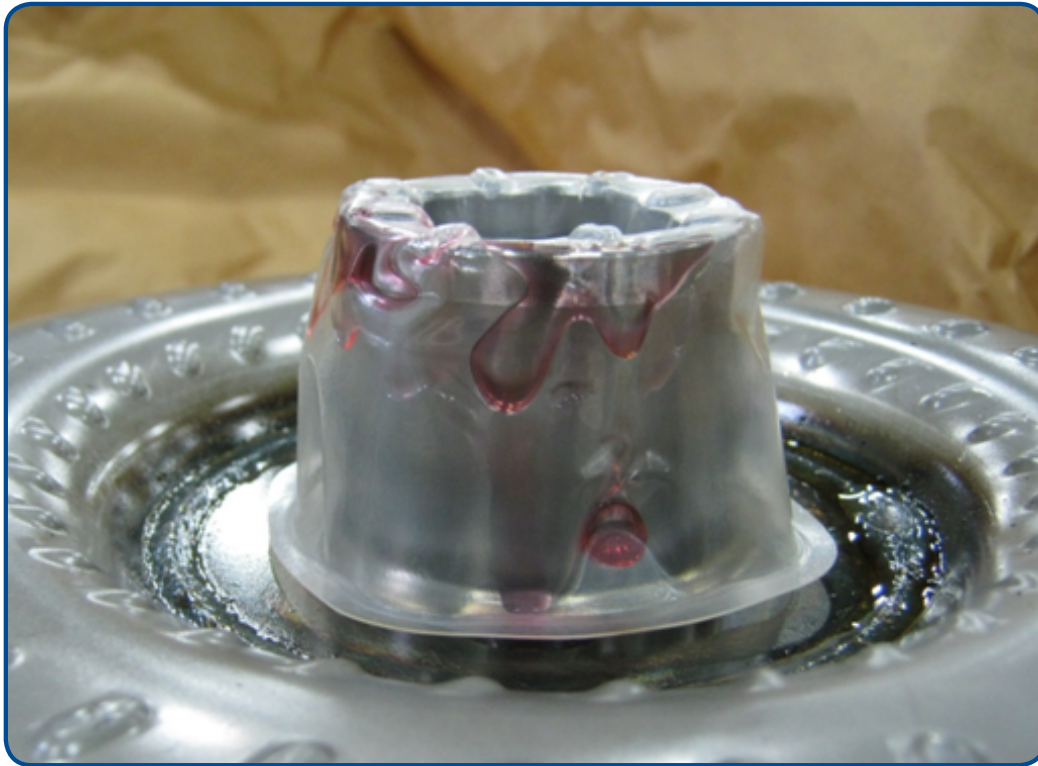
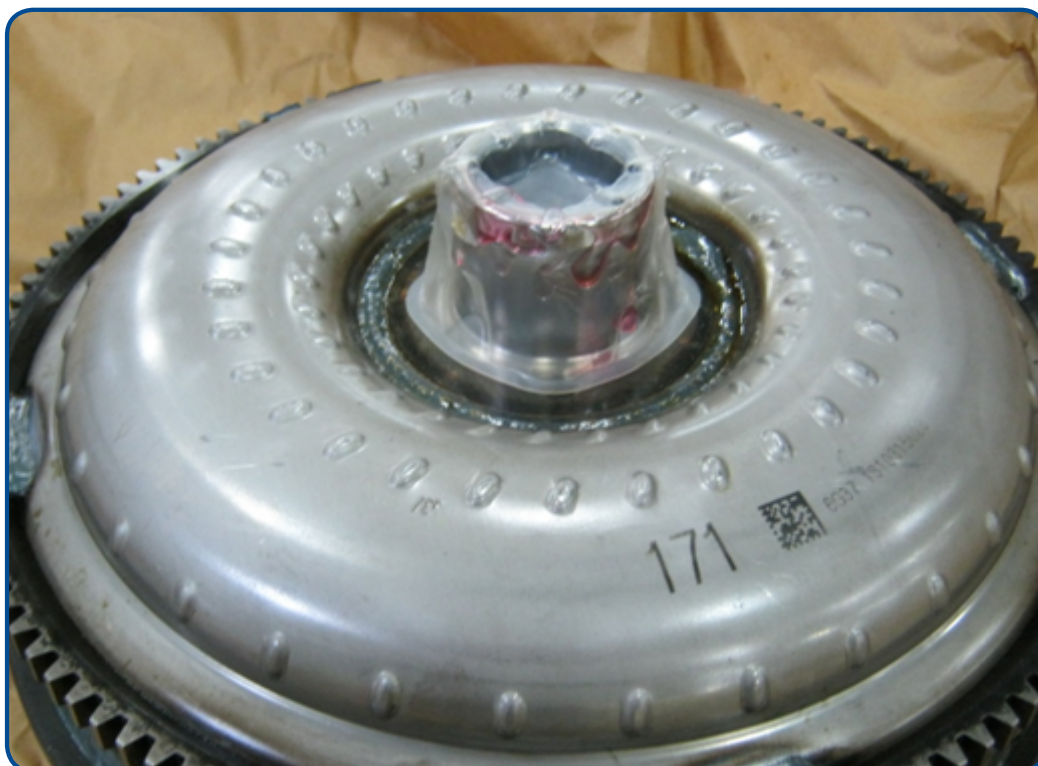
## 16 CVT TORQUE CONVERTERS

When replacing a torque converter on a CVT equipped vehicle, you may notice the appearance of RED colored fluid when unpacking the converter. This fluid is for shipping purposes and will not cause any harm when installed in either generation 1 or 2 CVT transmissions. See the photos below for examples of this fluid when the converter is unwrapped.
